R.M. Clayton WRC *E.Coli* Site Visit Report

Date of Visit: Thursday, March 7, 2024

Inspectors: Eddy Basilio and Reggie Williamson—GA EPD

Purpose of Site Visit: After receiving information from the Chattahoochee Riverkeeper, identifying that they suspected the R.M. Clayton WRC, owned and operated by the City of Atlanta, was the cause of an *E.coli* spike in the Chattahoochee River, EPD began investigating. After reviewing monthly operation reports for January 2024 and reviewing *E.coli* numbers from February 2024, EPD determined a site visit should be conducted to investigate the operation of the plant and attempt to determine the cause of the high *E.coli* in the plant. EPD was already aware of ongoing issues with the secondary clarifiers at the WRC and was aware that the City was making repairs on the units. Due to the concern of from the Riverkeeper, the high *E.coli* values from the WRC's effluent, and the clarifier issues that had been ongoing for months and still under repair, Eddy Basilio and Reggie Williamson went to conduct a site visit on Thursday, March 7, 2024. Below is the information and photographs gathered during the site visit.

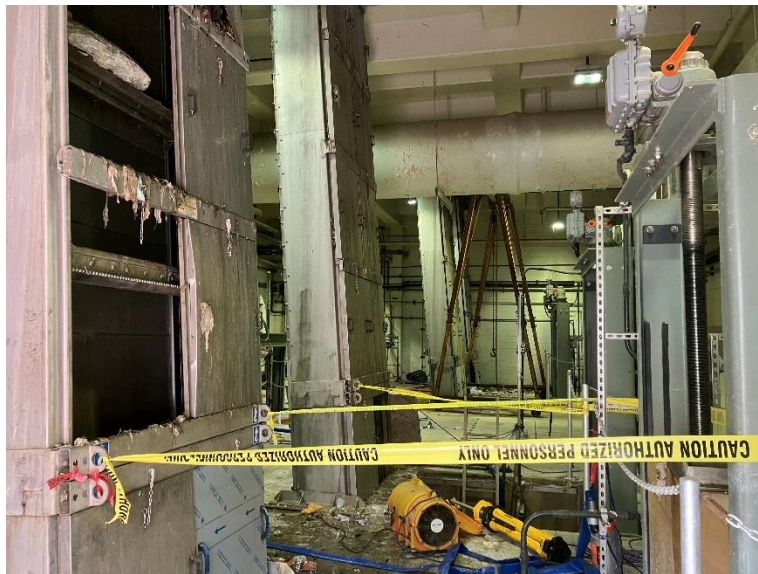
The WRC has 4 bar screens. At the time of the inspection, 1 of the bar screens was offline and came back online during the visit. The WRC has 3 drum screens. EPD was informed that one of the drum screens had just been refurbished and should be back in operation soon, with the second one to then go through the same process. At the time of the visit, none of the drum screens were operational.

Preliminary Screen Photo 1: Bar Screens

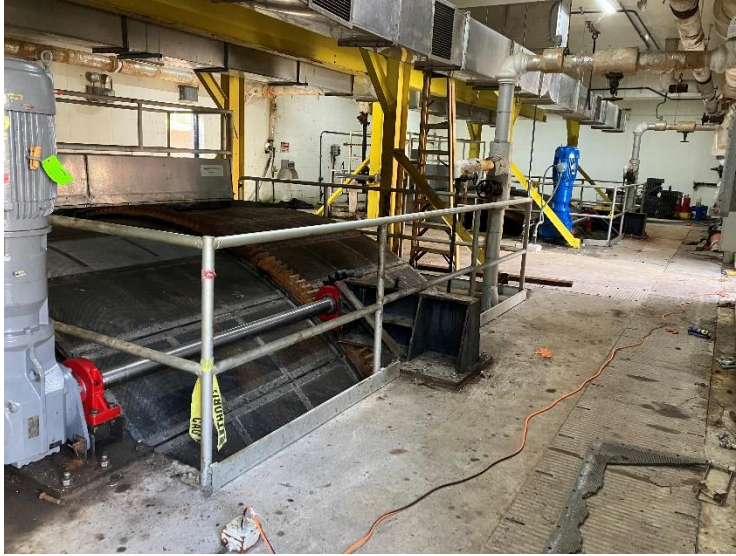
Preliminary Screening Photo 2: Drum Screens

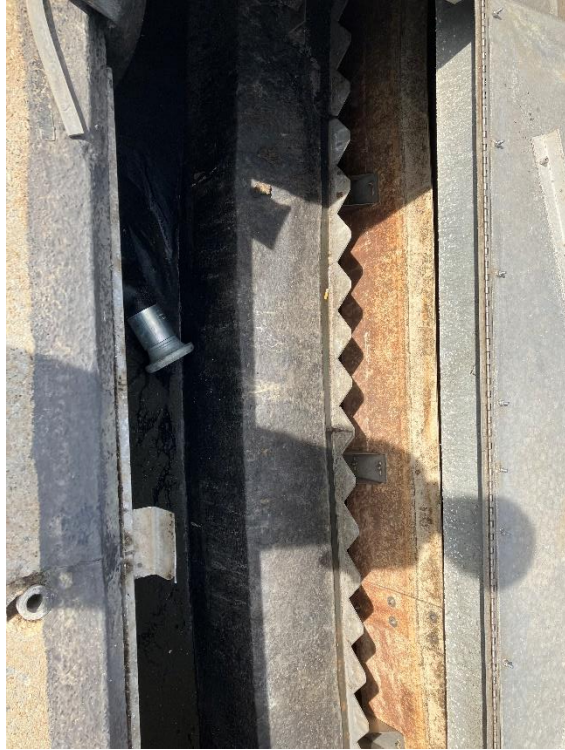
The facility has 8 primary clarifiers. At the time of the visit, only 2 primary clarifiers were operational (primary clarifiers #5 and #7), with a third being mixed with a pump so it can be drained and re-filled to put into operation (primary clarifier #8). The repair for the gate on primary clarifier #4 was completed the day of the visit. EPD was informed that the facility was running with no operational primary clarifiers up until about a month prior to the visit.

Primary Clarification Photo 1: Primary Clarifier

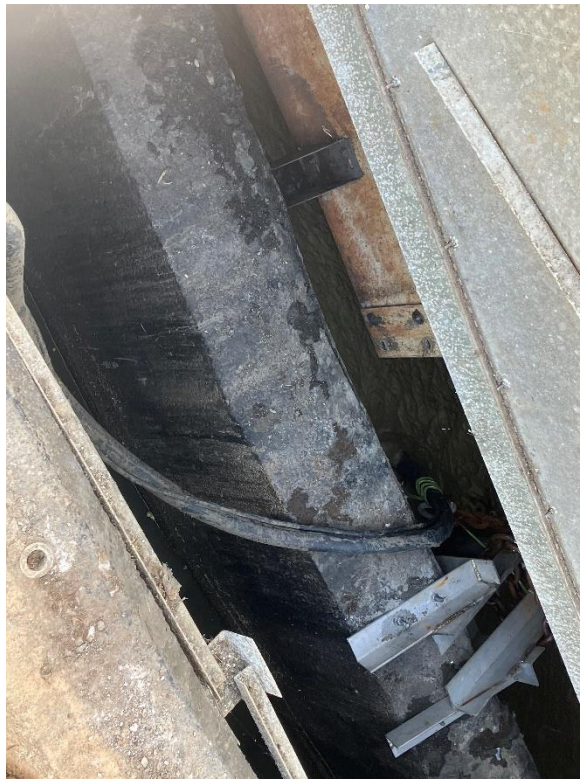
Primary Clarification Photo 2: Primary Clarifier being Mixed

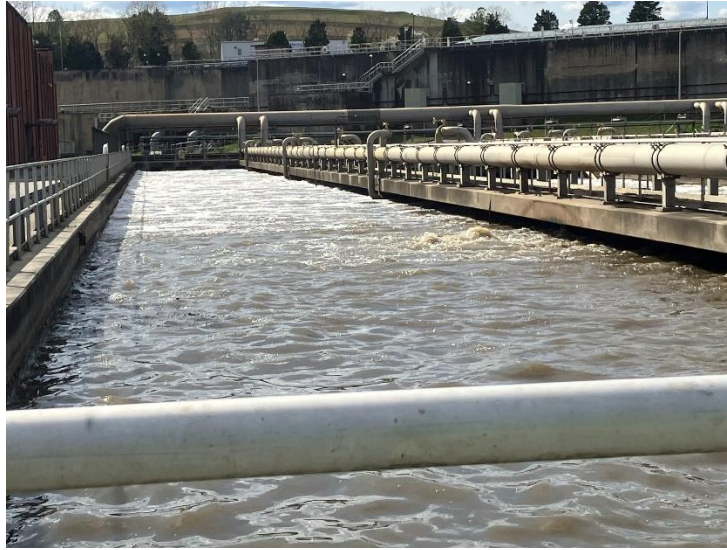
The WRC has 14 biological nutrient reduction (BNR) basins. BNR basins #3 and #9 had been drained to repair the headers and diffusers. BNR basin #14 was actively being drained at the time of the visit for diffuser repairs. EPD noticed large bubbling indicating broken diffusers in 2 BNR basins. When flow is heavy, the plant will run the basins with broken diffuser to help treat more flow.

BNR Photo 1: BNR (1)

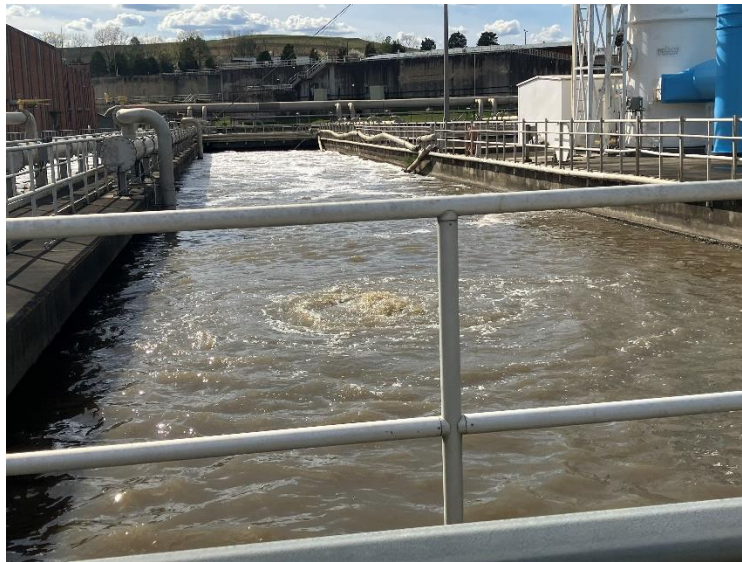
BNR Photo 2: BNR (2)

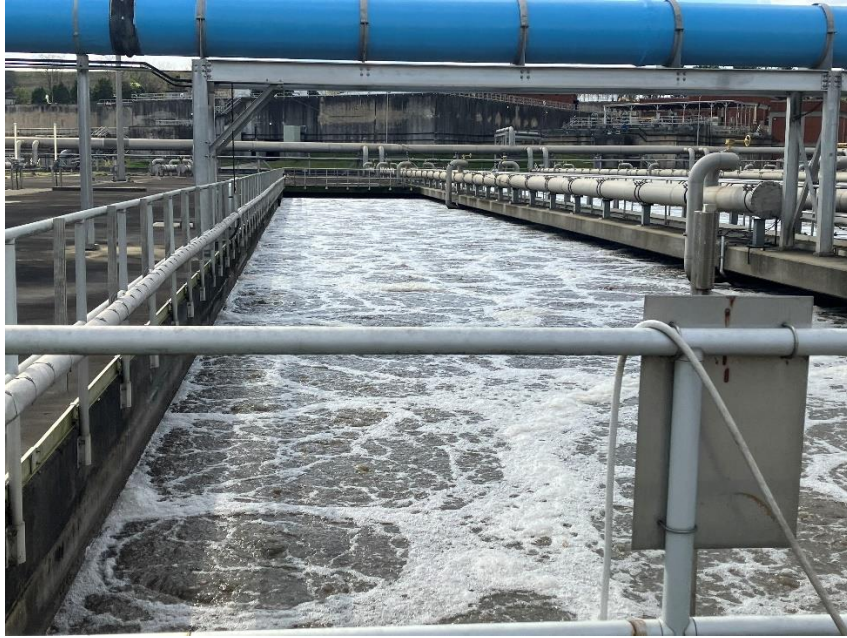
BNR Photo 3: BNR (3)

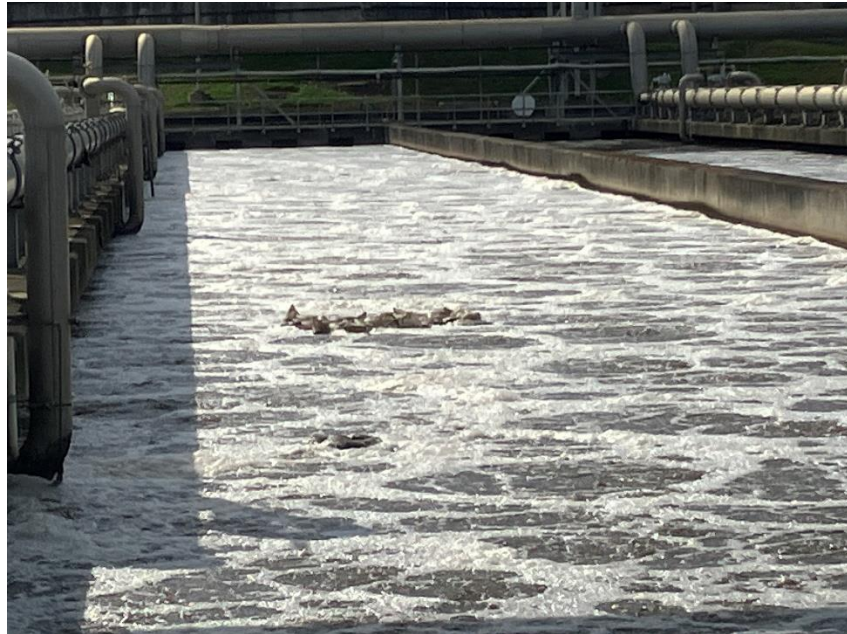
BNR Photo 4: Solids in a BNR Basin

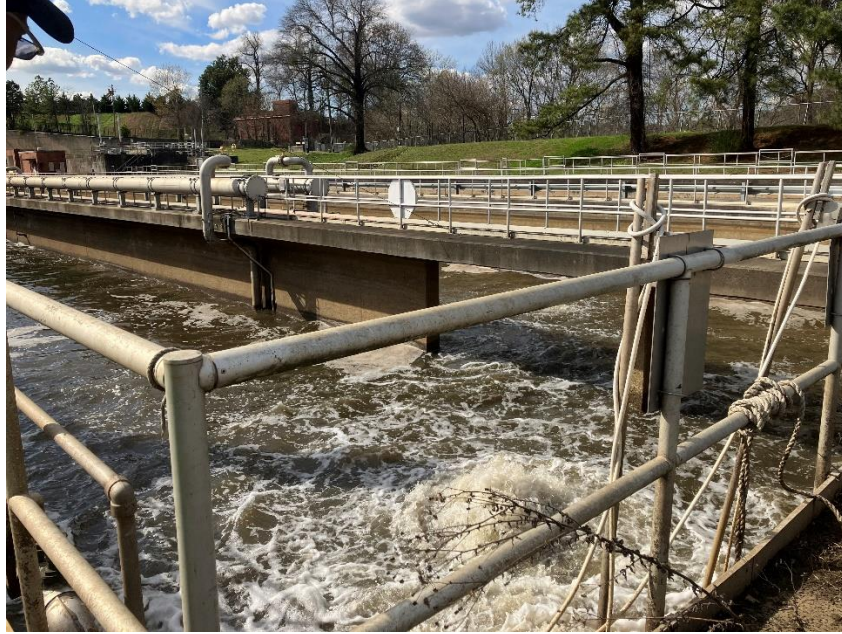
BNR Photo 5: BNR Basin #14 being drained

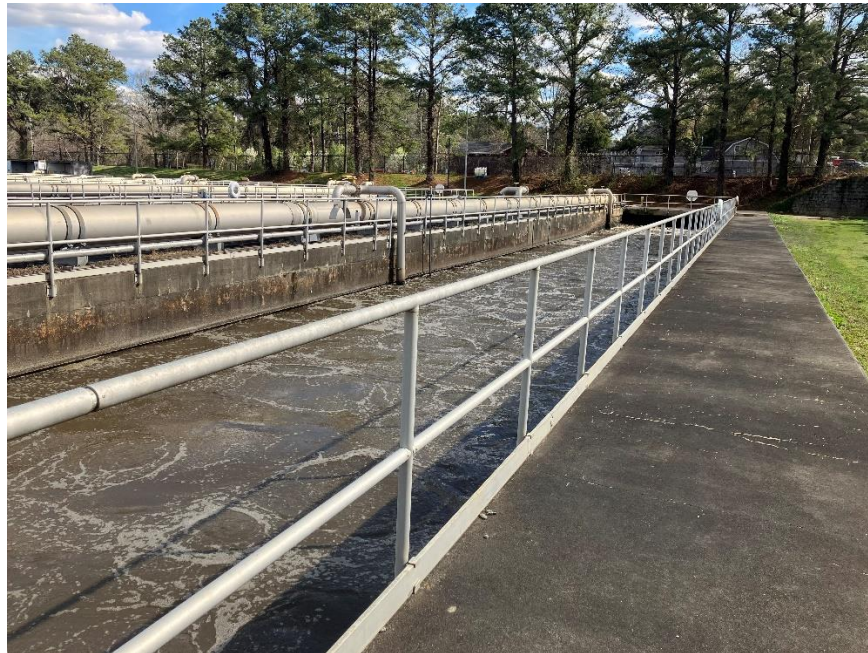
BNR Photo 5: BNR Basin (4)

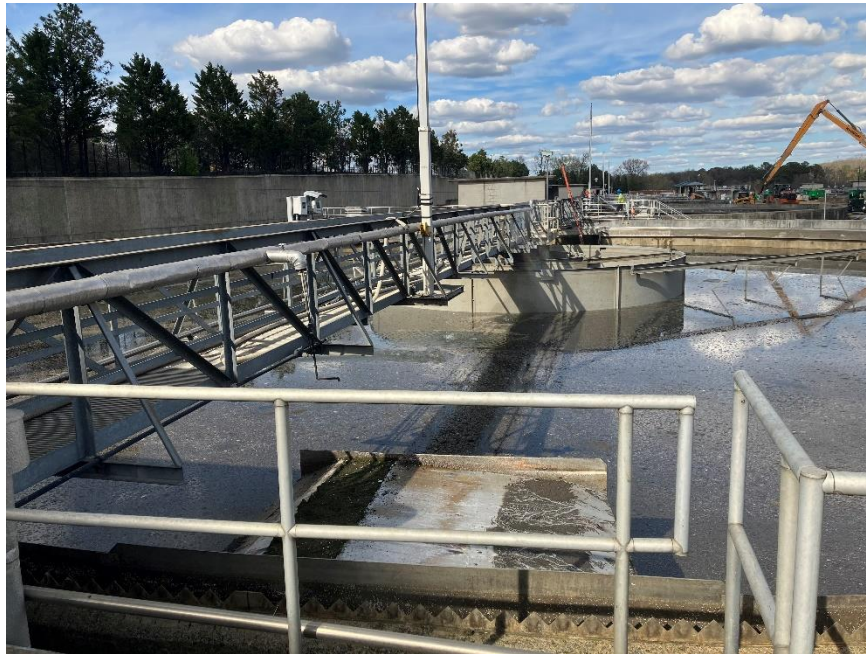
#2, #3, #4, and #9) have external pumps to return flow to the system and reduce the amount of flow going to the one operational clarifier. EPD was informed that there is a schedule for the repairs to the clarifiers that are permanently out-of-service.

SC Photo 1: Secondary Clarifier #1

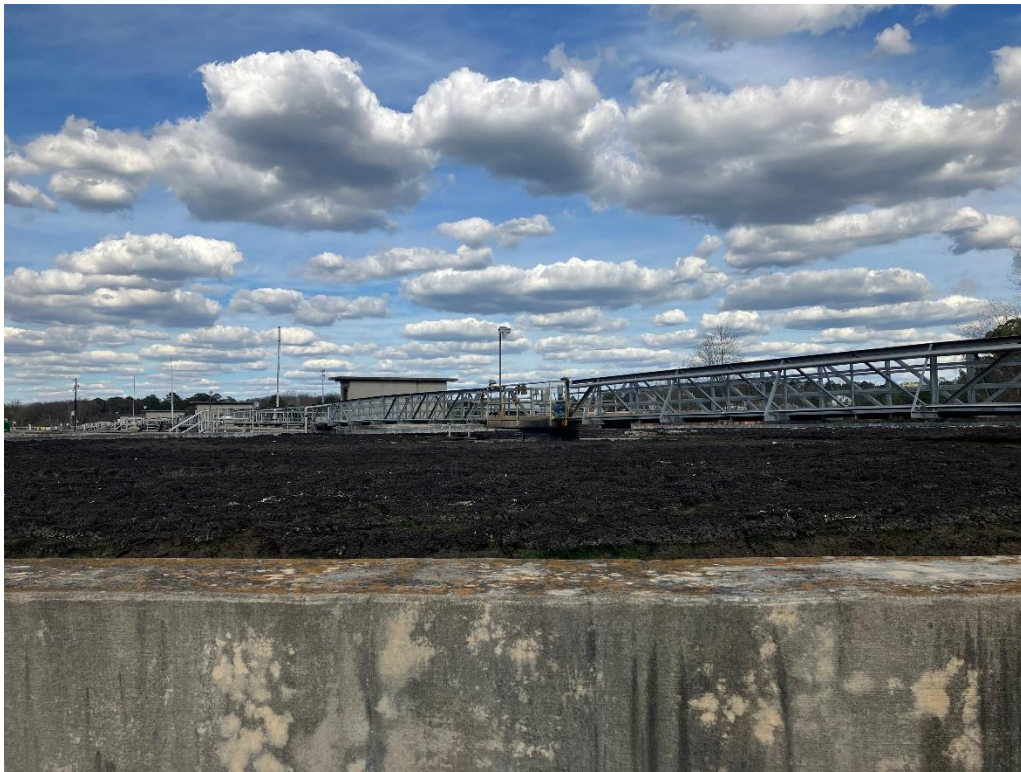
SC Photo 2: Secondary Clarifier #4

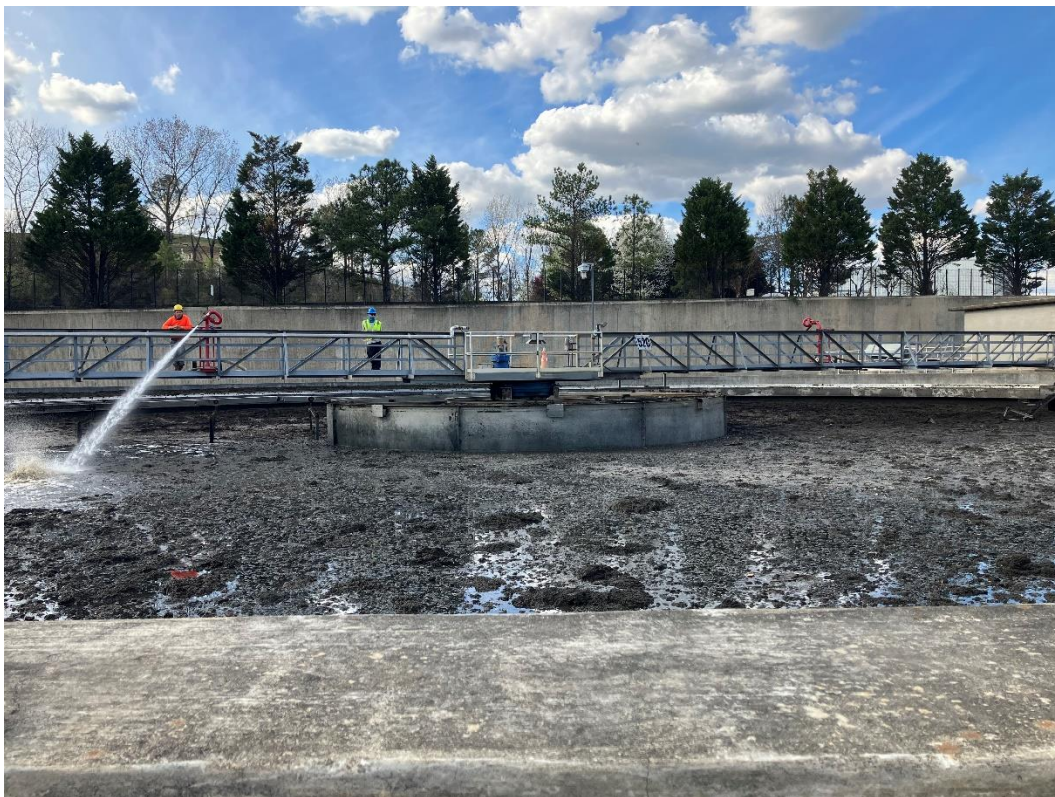
SC Photo 3: Secondary Clarifier #3

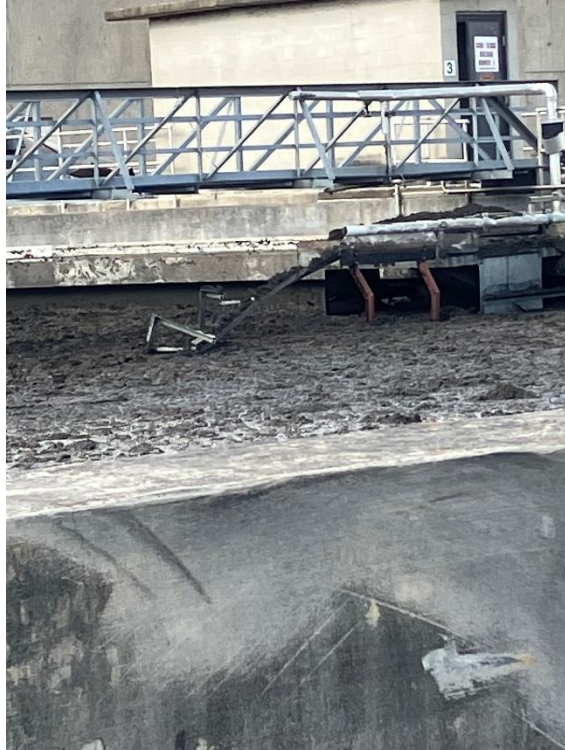
SC Photo 4: Broken arm on secondary clarifier #3

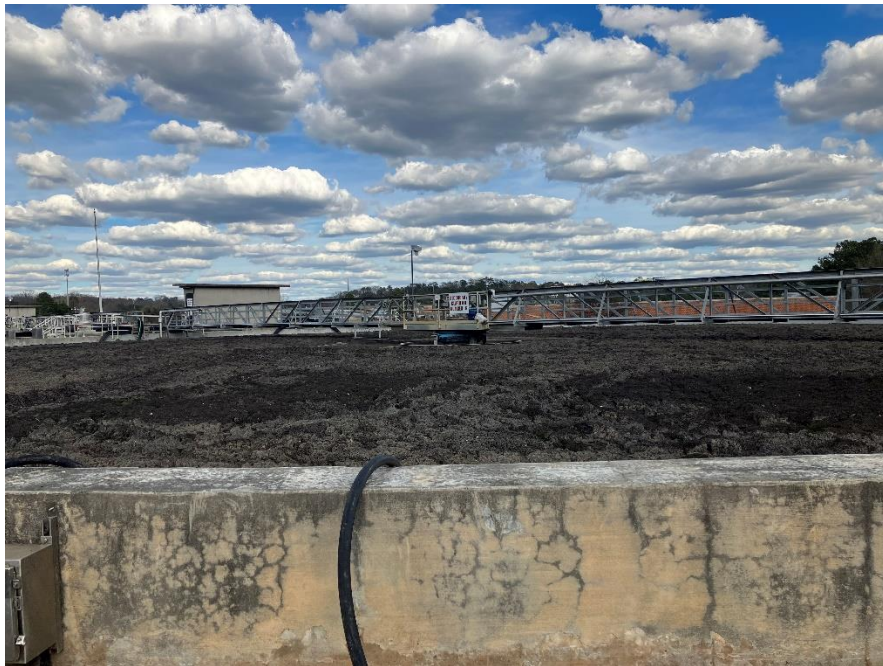
Upon the start of the plant walkthrough, EPD was notified that secondary clarifier #7 had went down that morning because it torqued out and that secondary clarifier #10 was the only secondary clarifier that was operational. Secondary clarifiers #5, #6, and #8 are permanently out-of-service until repairs are made to the units to fix the center spindle. The remaining secondary clarifiers (#1,

SC Photo 5: Secondary Clarifier #6

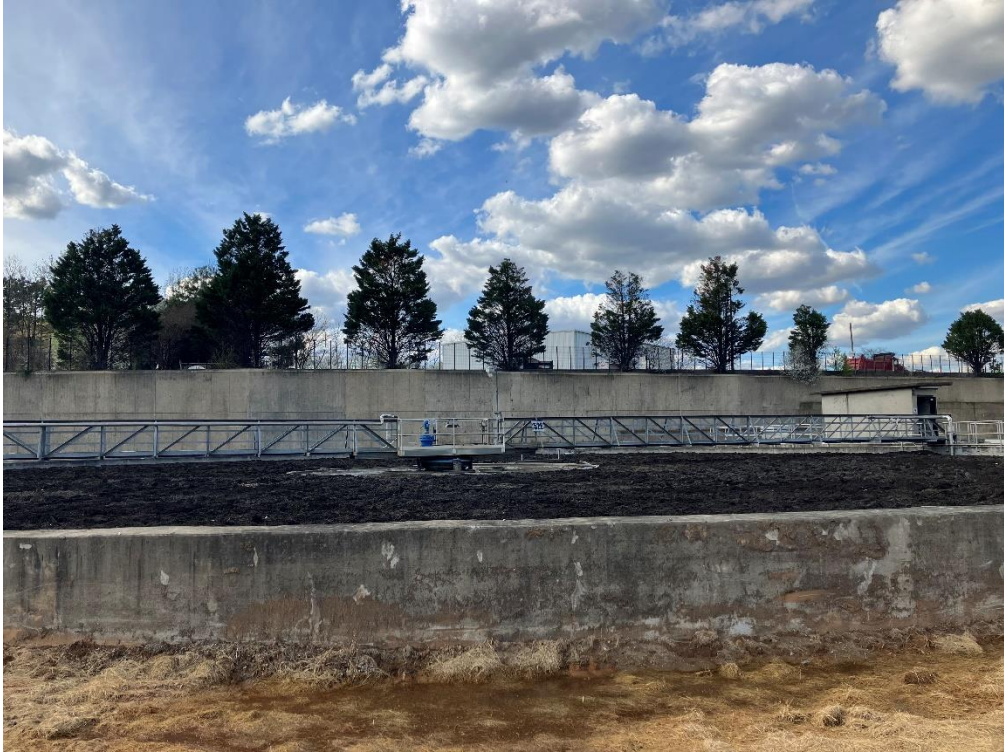
SC Photo 6: Secondary Clarifier #5

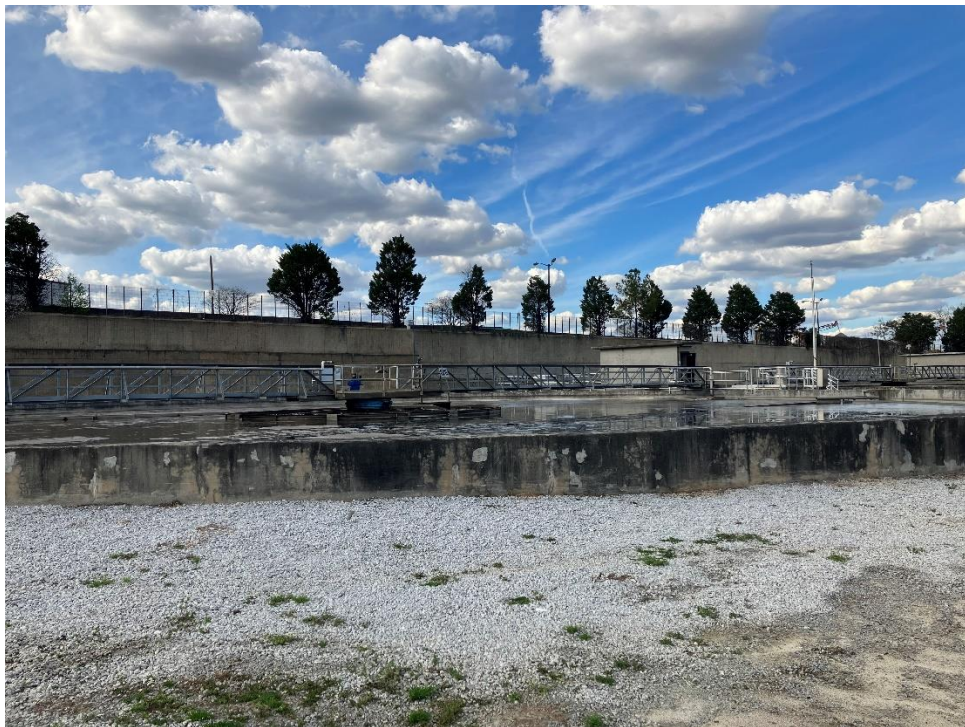
SC Photo 7: Secondary Clarifier #7

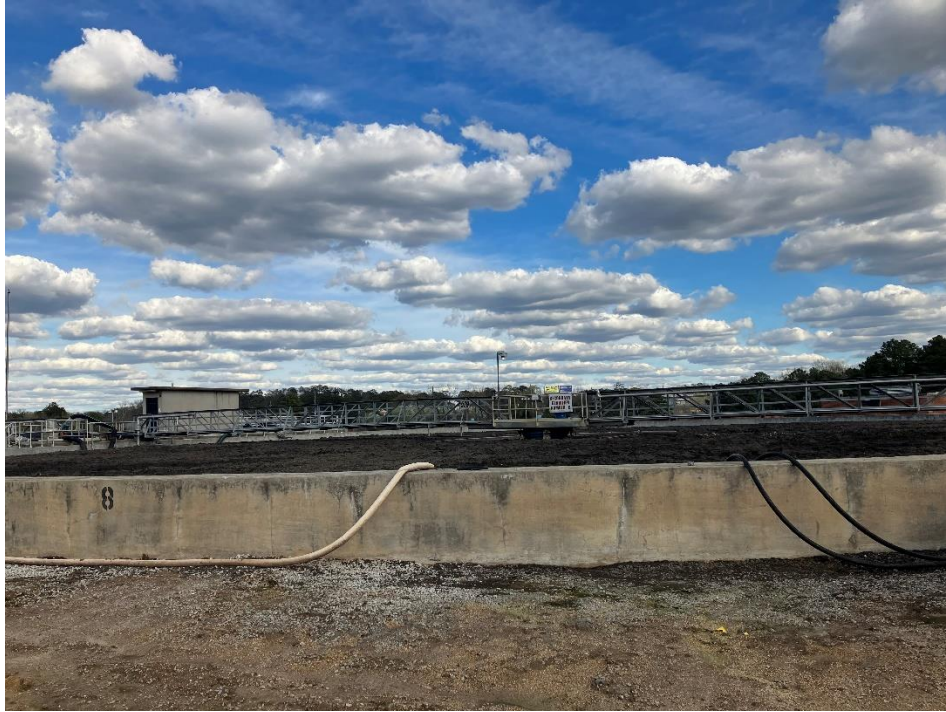
SC Photo 8: Secondary Clarifier #8

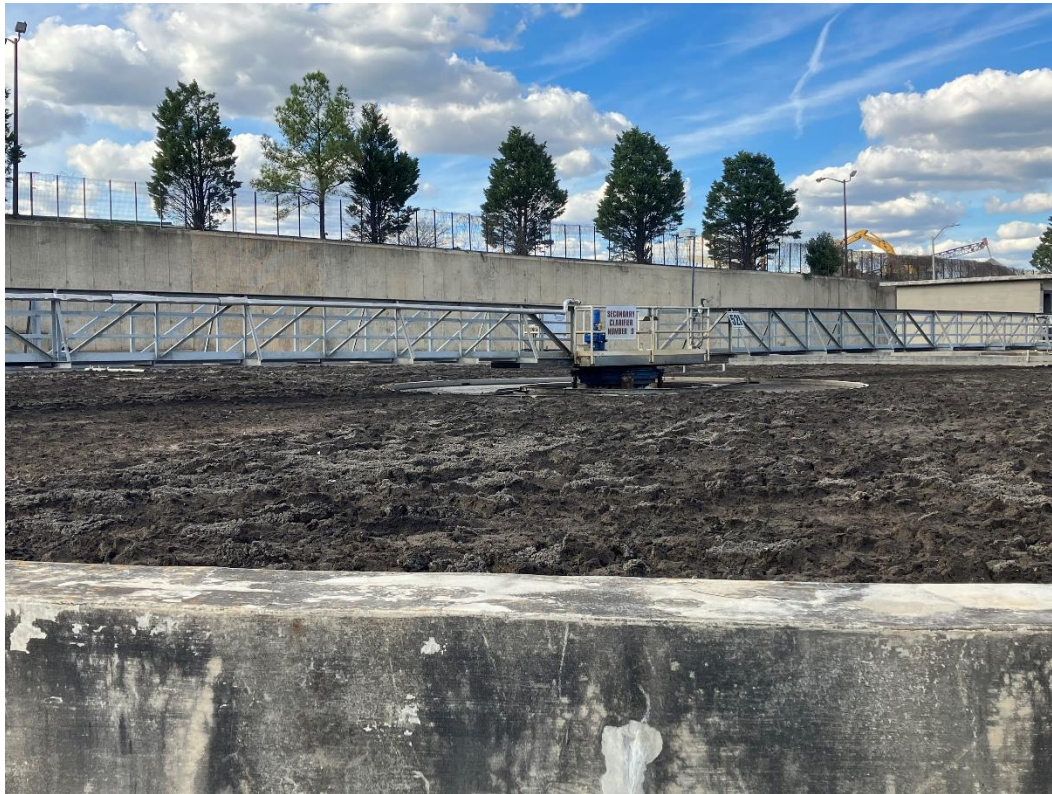
SC Photo 9: Secondary Clarifier #9

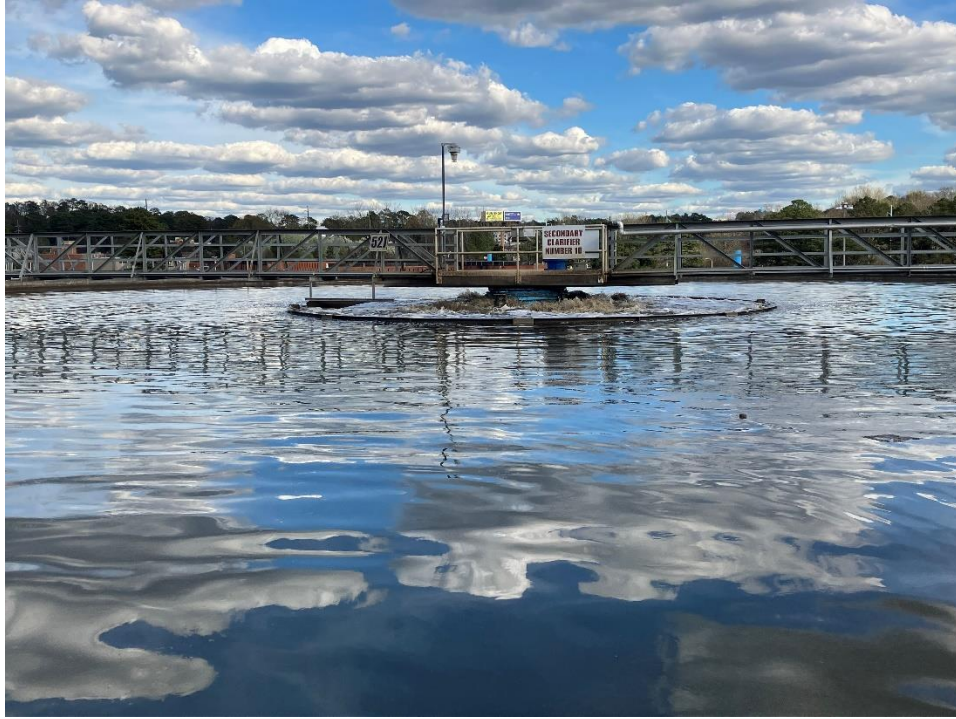
SC Photo 10: Secondary Clarifier #10

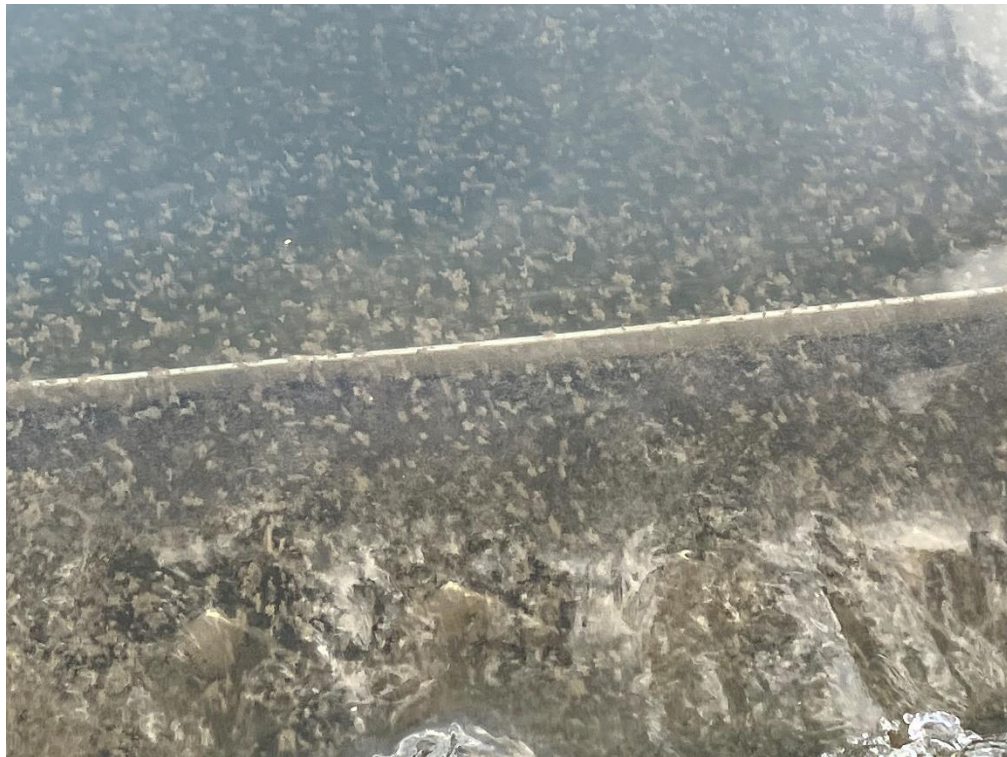
SC Photo 11: Solids in Secondary Clarifier #10 Effluent

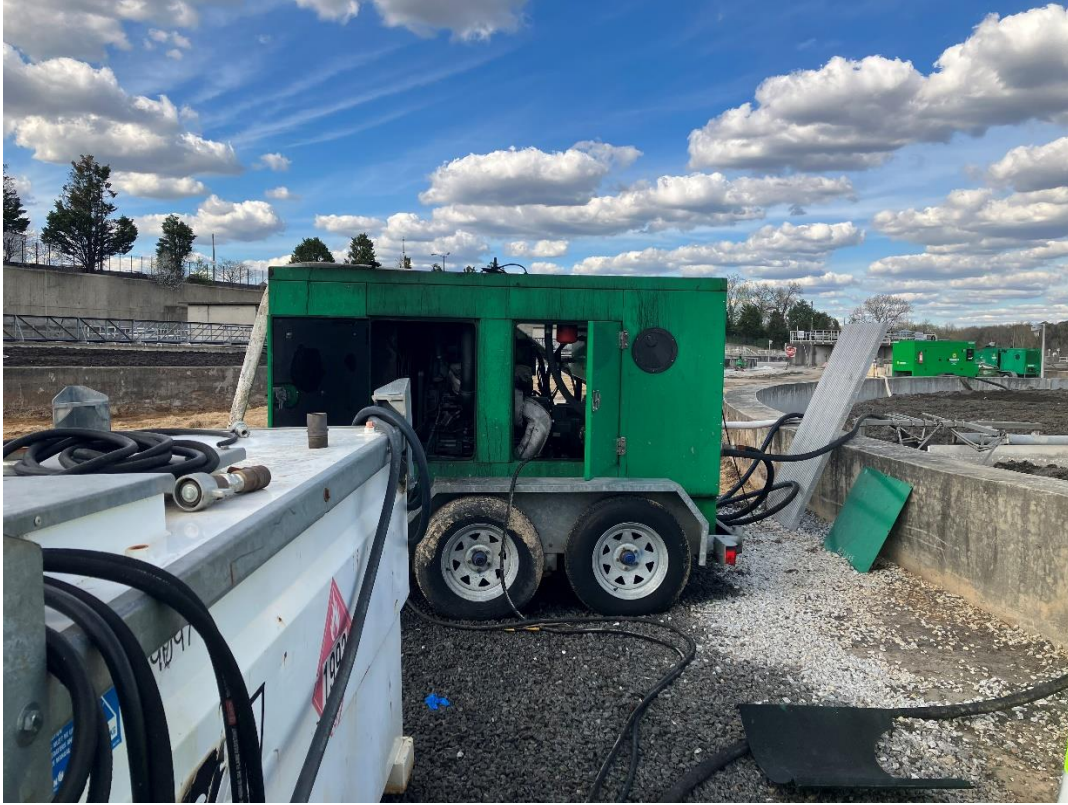
SC Photo 12: Pumps Used to Return Clarifier Flow to System

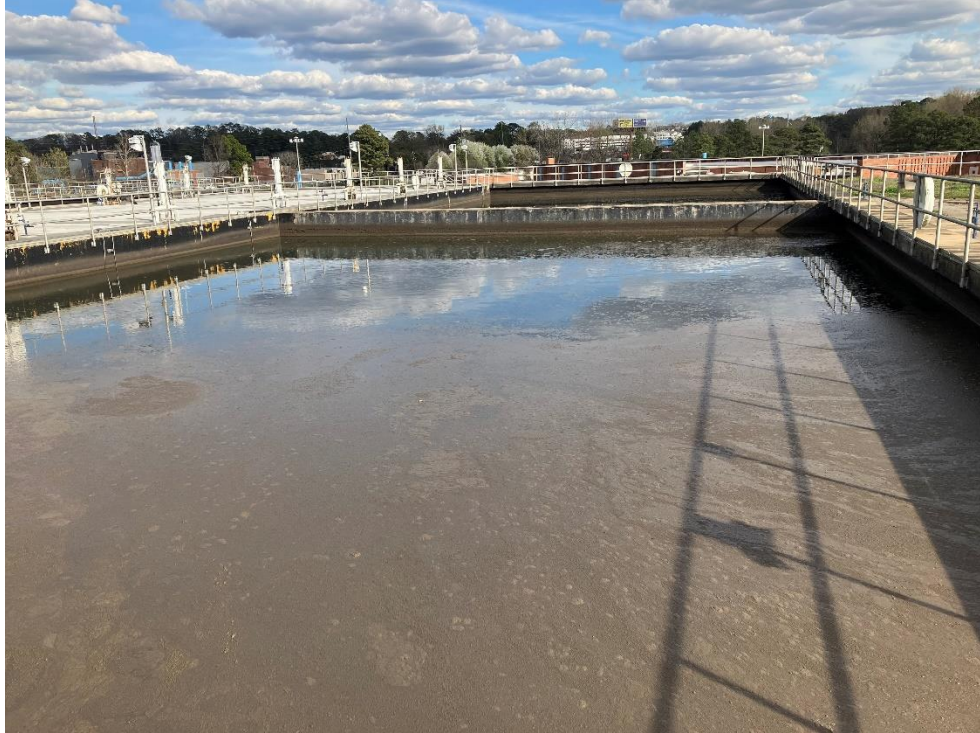
The facility has 22 sand filters that serve as tertiary treatment for the system. At the time of the visit, filters #18, #20, and #22 were offline. One filter was backwashing. The remainder of the filters were ponded, with the ponding so high that the filters were not visible.

Tertiary Treatment Photo 1: Sand Filters (1)

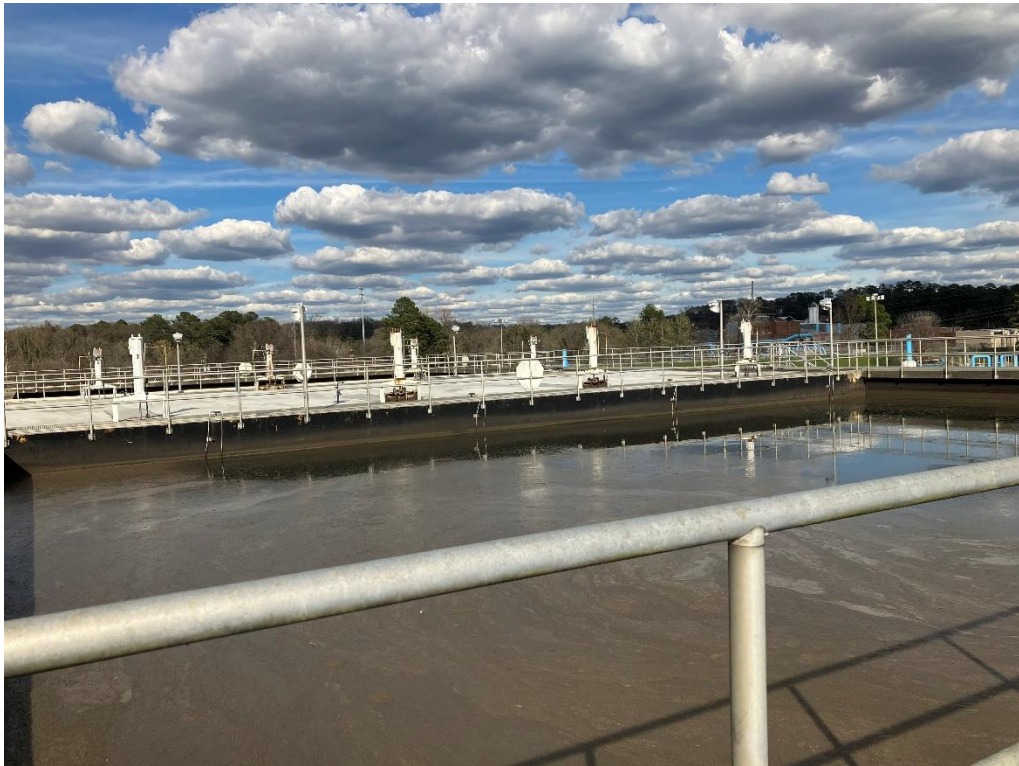
Tertiary Treatment Photo 2: Sand Filters (2)

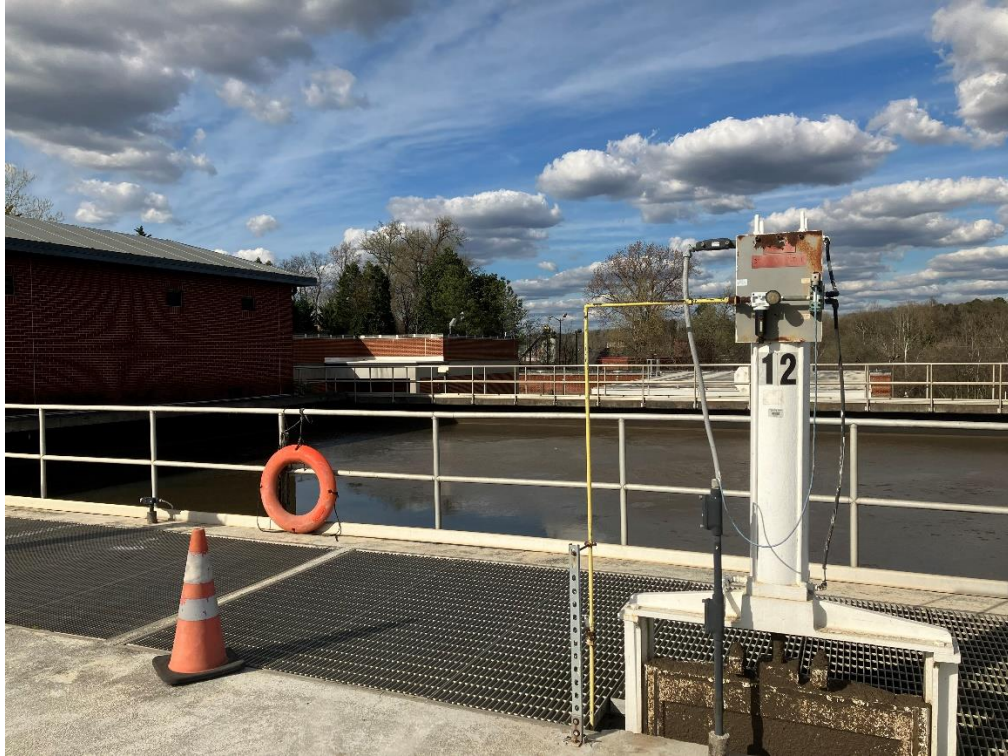
Tertiary Treatment Photo 3: Sand Filters (3)

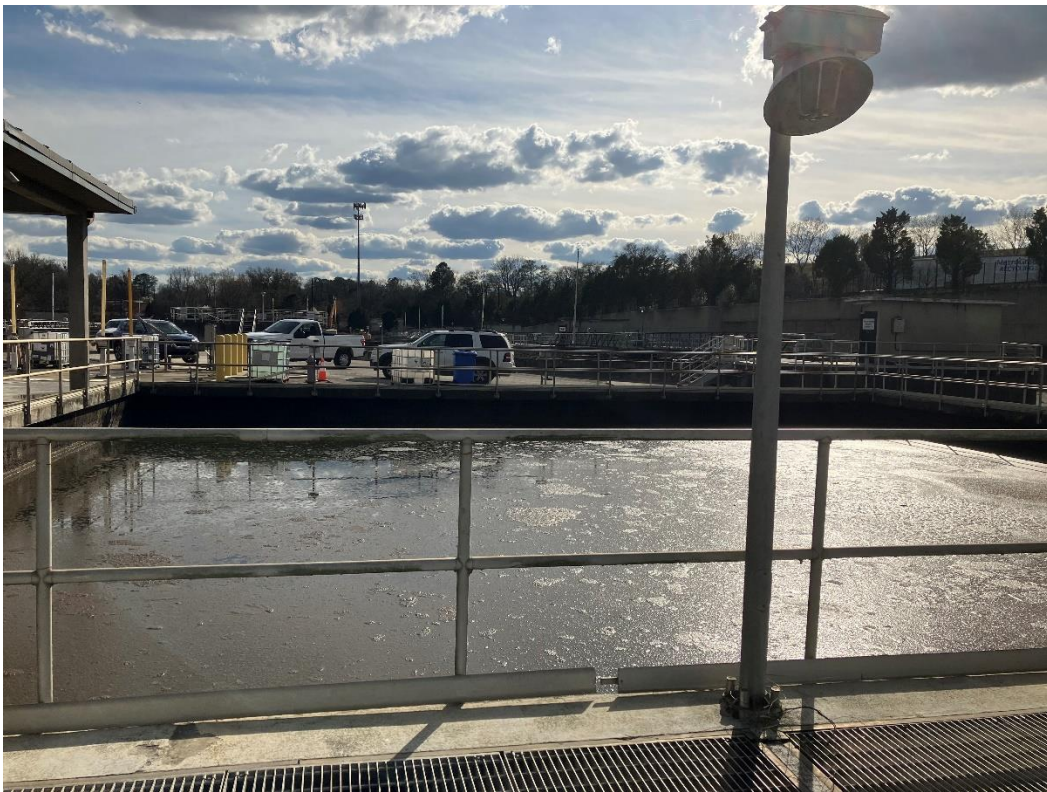
Tertiary Treatment Photo 4: Sand Filters (4)

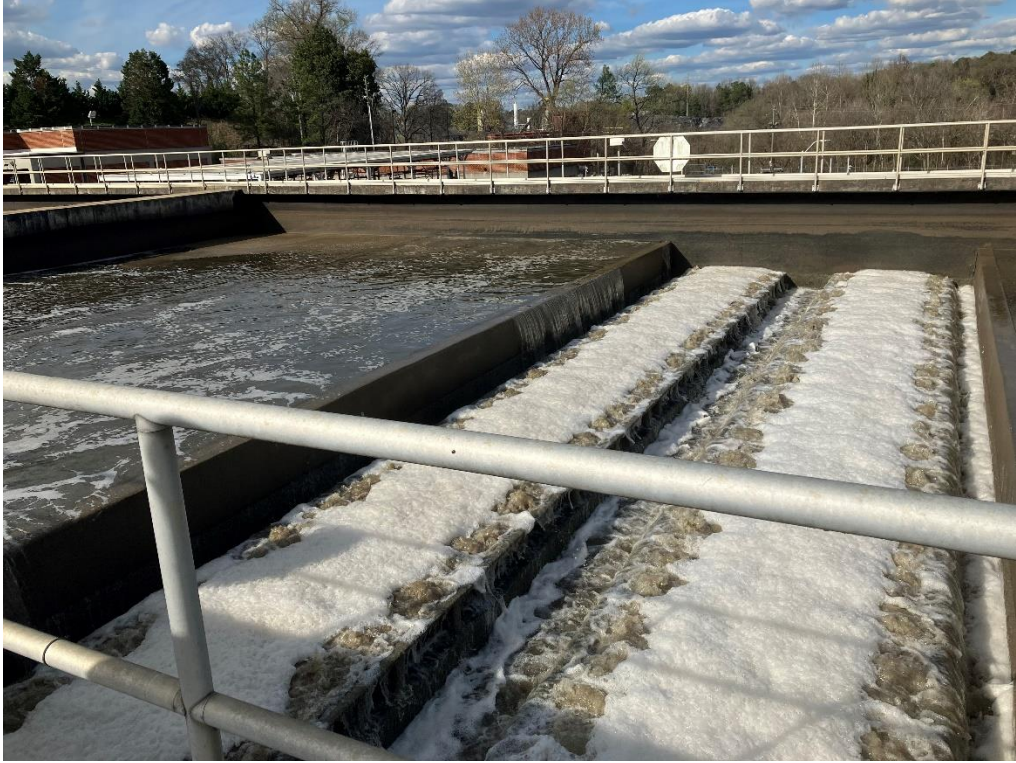
Tertiary Treatment Photo 5: Sand Filters Backwashing

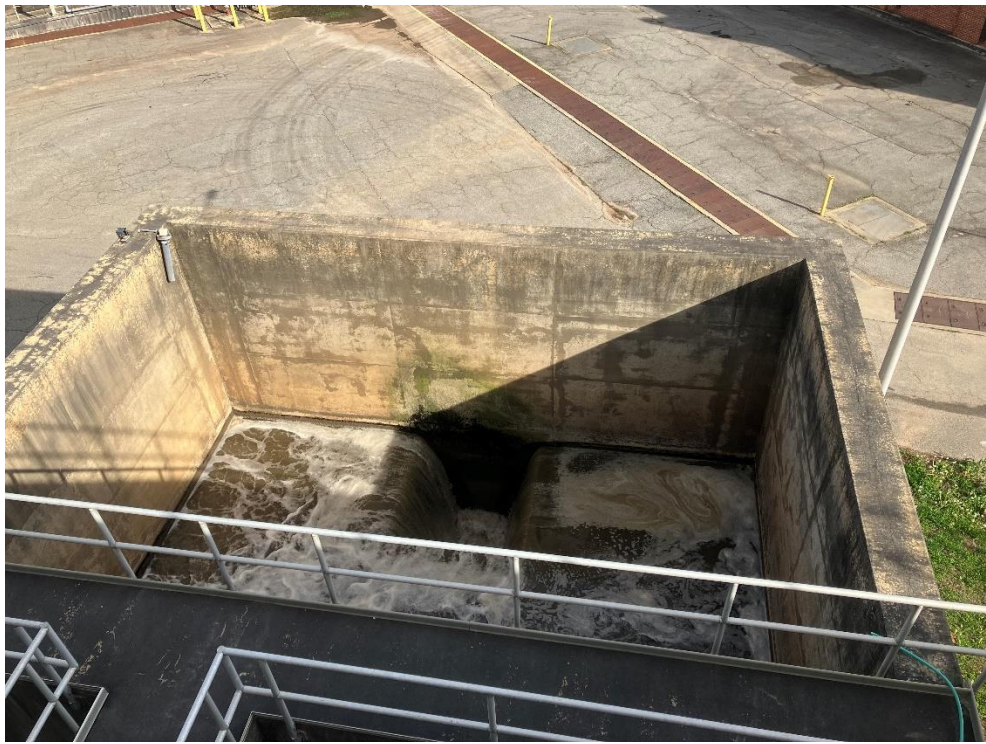
Tertiary Treatment Photo 6: Sand Filter Backwash Flow to BNRs

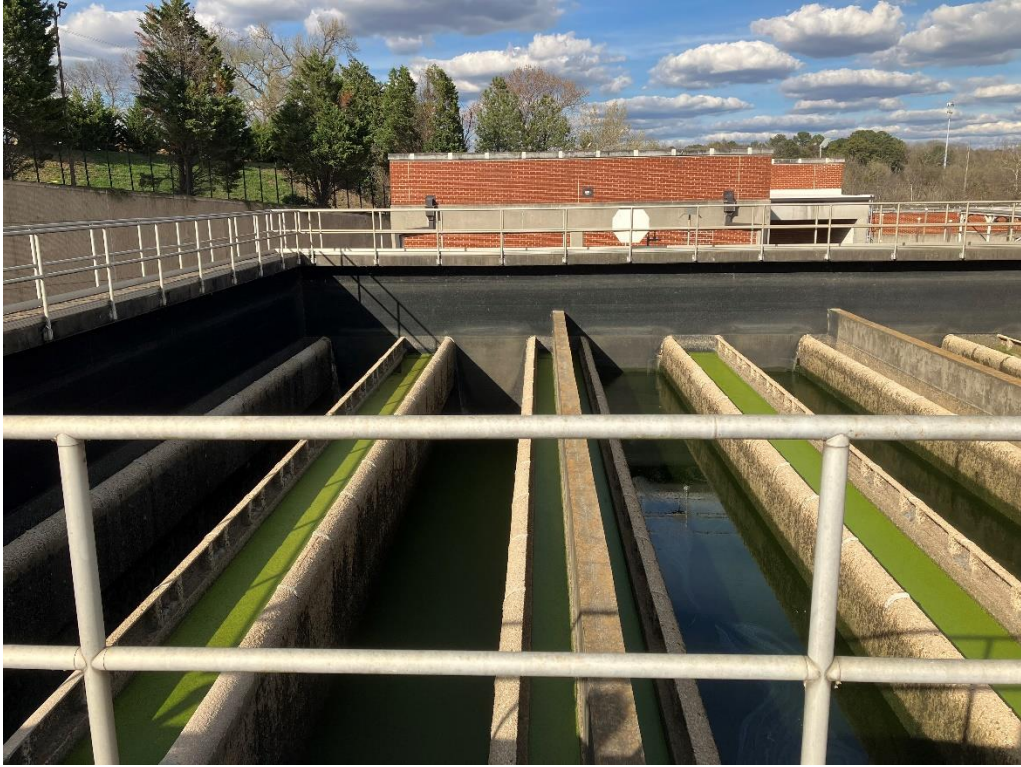
Tertiary Treatment Photo 7: Offline Sand Filters (1)

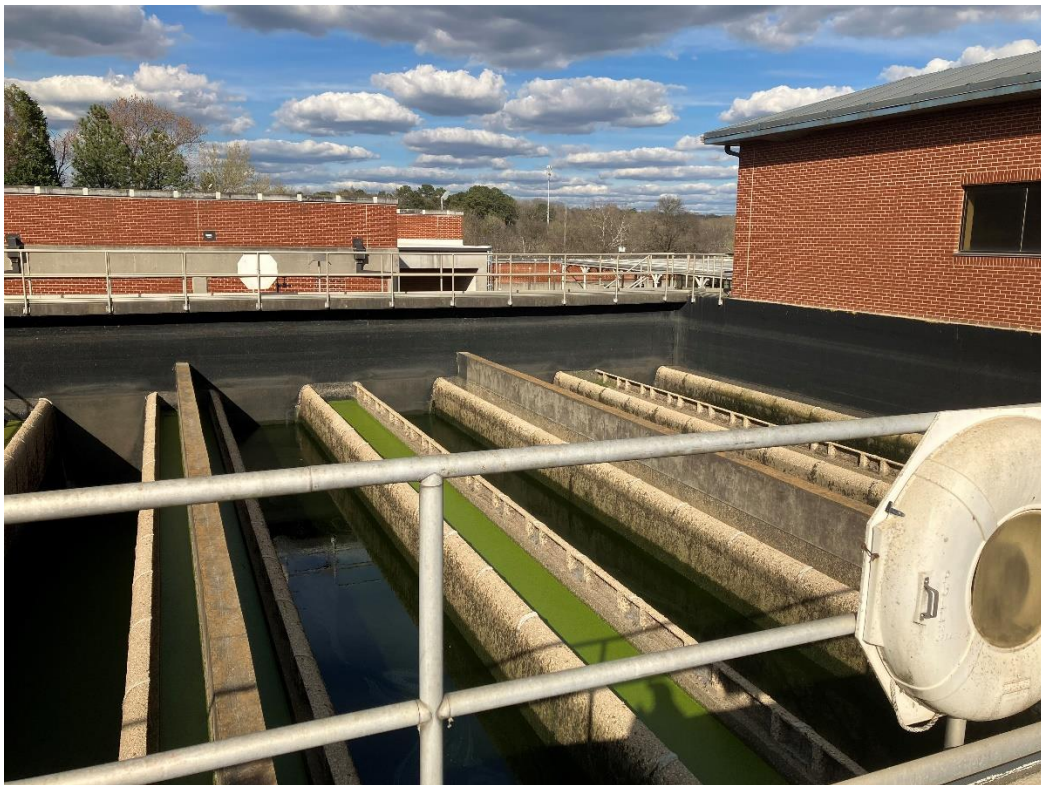
Tertiary Treatment Photo 8: Offline Sand Filters (2)

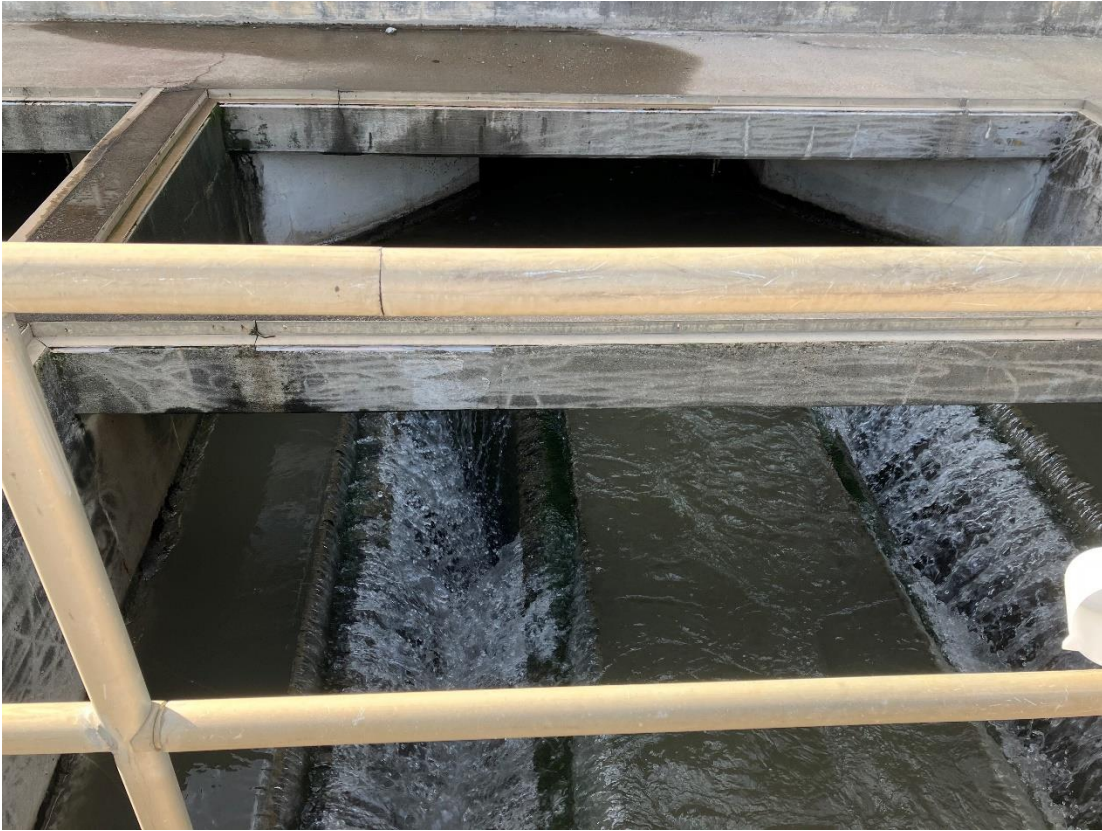
There are 4 UV channels to disinfect the effluent before it is discharged to the Chattahoochee River. At the time of the visit, one of the trains was offline. The offline train has lots of plant growth in it. The other 3 UV trains were online. There were visible solids on the side walls where the UV treated effluent was discharged to head to the outfall. The UV treated effluent had a light brown color to it.

Disinfection Photo 1: UV Flow

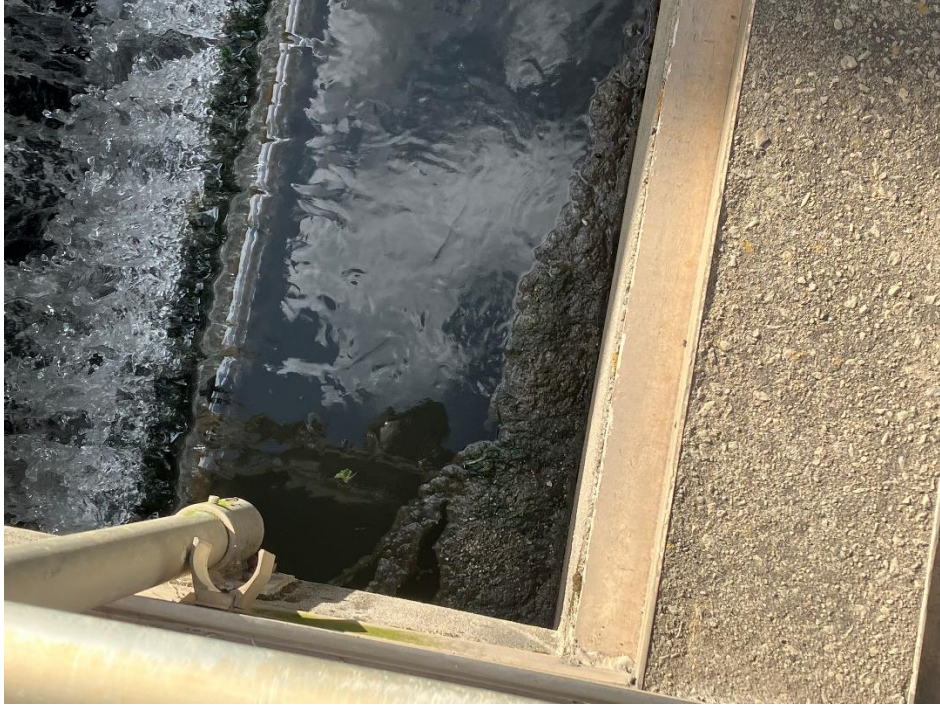
Disinfection Photo 2: Solids on Walls of UV Treated Effluent (1)
