R.M. Clayton WRC *E.Coli* Site Visit Report

Date of Visit: Thursday, March 7, 2024

Inspectors: Eddy Basilio and Reggie Williamson—GA EPD

Purpose of Site Visit: After receiving information from the Chattahoochee Riverkeeper, identifying that they suspected the R.M. Clayton WRC, owned and operated by the City of Atlanta, was the cause of an *E.coli* spike in the Chattahoochee River, EPD began investigating. After reviewing monthly operation reports for January 2024 and reviewing *E.coli* numbers from February 2024, EPD determined a site visit should be conducted to investigate the operation of the plant and attempt to determine the cause of the high *E.coli* in the plant. EPD was already aware of ongoing issues with the secondary clarifiers at the WRC and was aware that the City was making repairs on the units. Due to the concern of from the Riverkeeper, the high *E.coli* values from the WRC's effluent, and the clarifier issues that had been ongoing for months and still under repair, Eddy Basilio and Reggie Williamson went to conduct a site visit on Thursday, March 7, 2024. Below is the information and photographs gathered during the site visit.

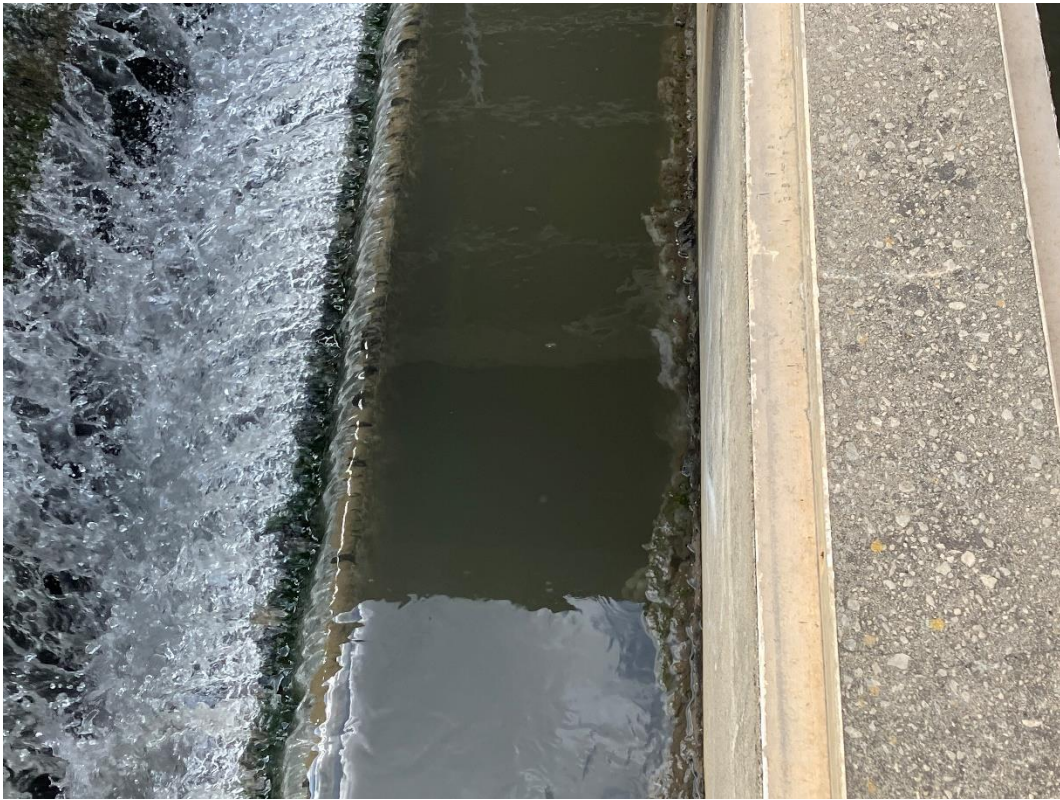
There are 4 UV channels to disinfect the effluent before it is discharged to the Chattahoochee River. At the time of the visit, one of the trains was offline. The offline train has lots of plant growth in it. The other 3 UV trains were online. There were visible solids on the side walls where the UV treated effluent was discharged to head to the outfall. The UV treated effluent had a light brown color to it.

Disinfection Photo 3: Solids on Walls of UV Treated Effluent (2)

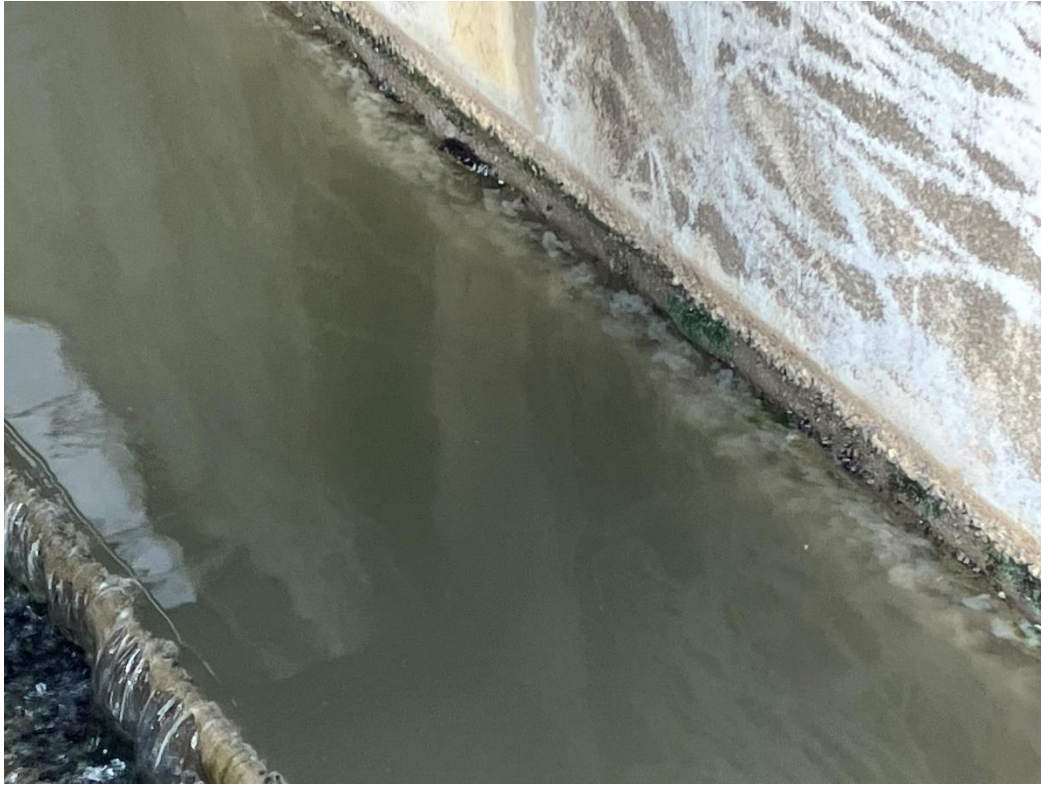
Disinfection Photo 4: Solids on Walls of UV Treated Effluent (3)

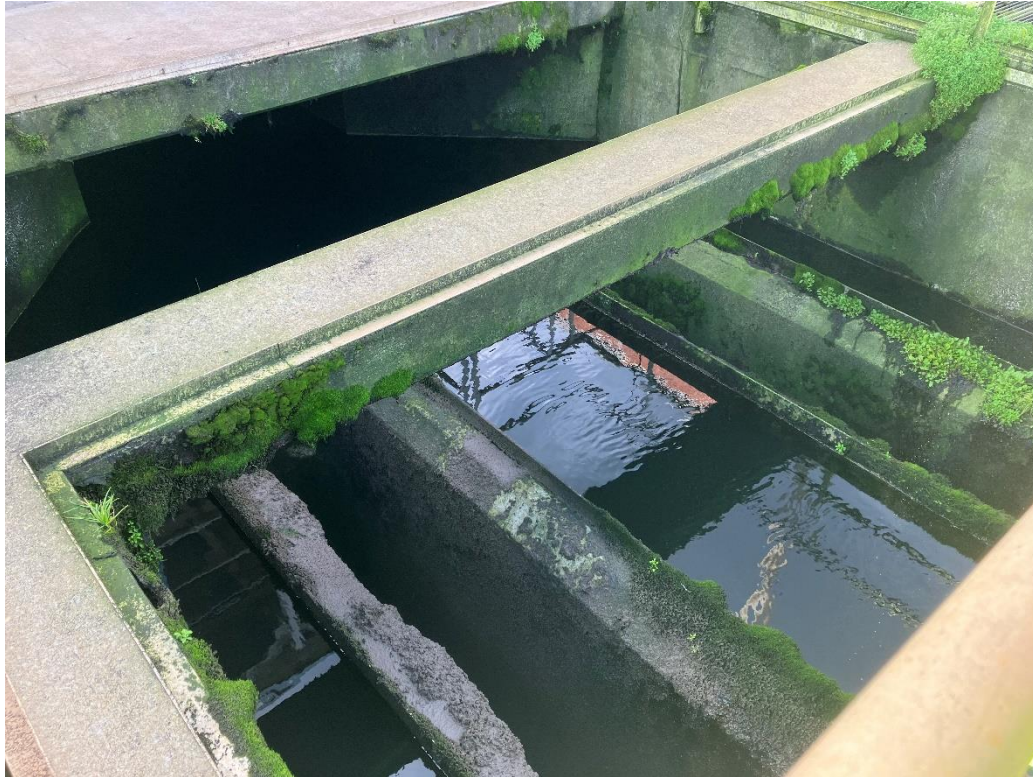
Disinfection Photo 5: Offline UV Channel

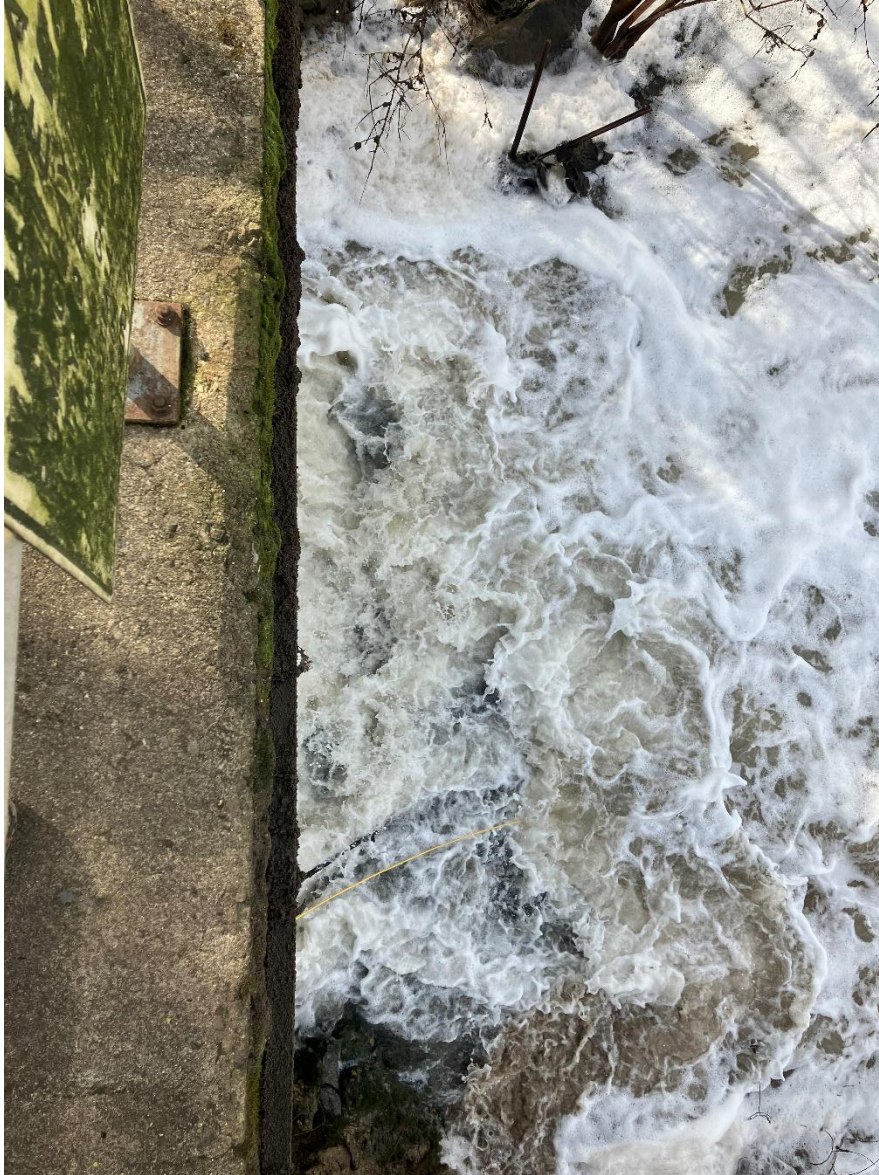
At the outfall, there was evidence of high solids in the treated effluent. There was foam exiting the outfall and flowing downstream in the Chattahoochee River. The outfall identification sign was illegible. This was noted in the April 2023 inspection and the sign had not been replaced. As of Friday, March 8th, the outfall identification sign has been replaced at the facility.

Effluent Discharge Photo 1: Effluent from Outfall

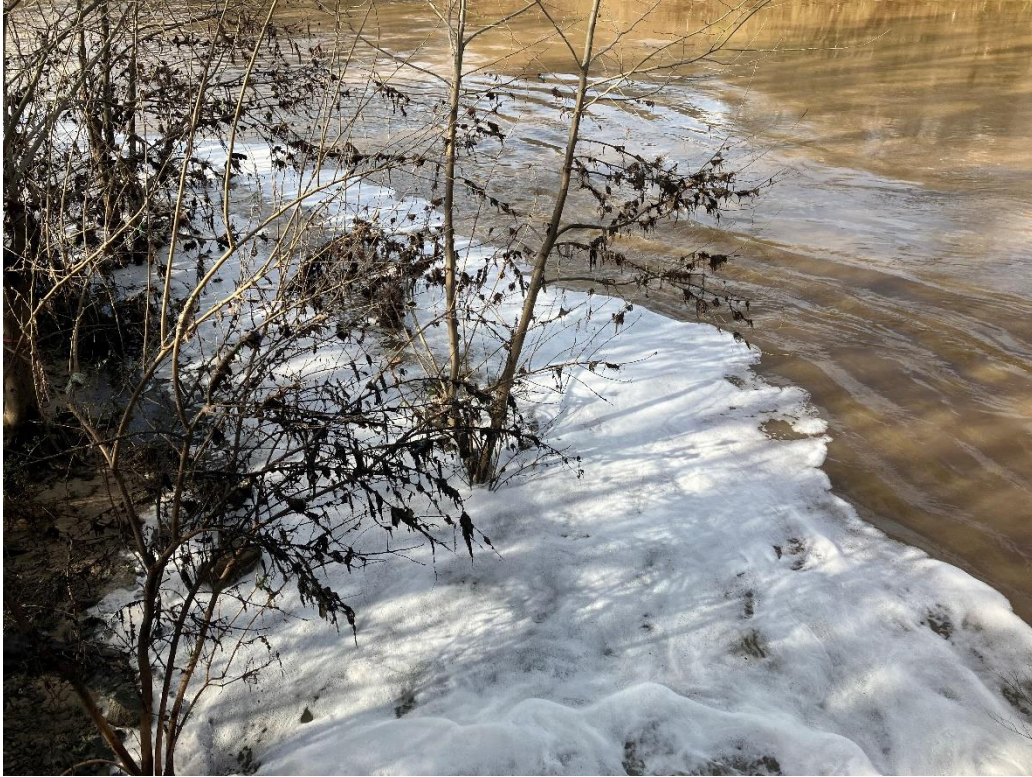
Effluent Discharge Photo 2: Effluent Traveling Downstream of the Chattahoochee River (1)

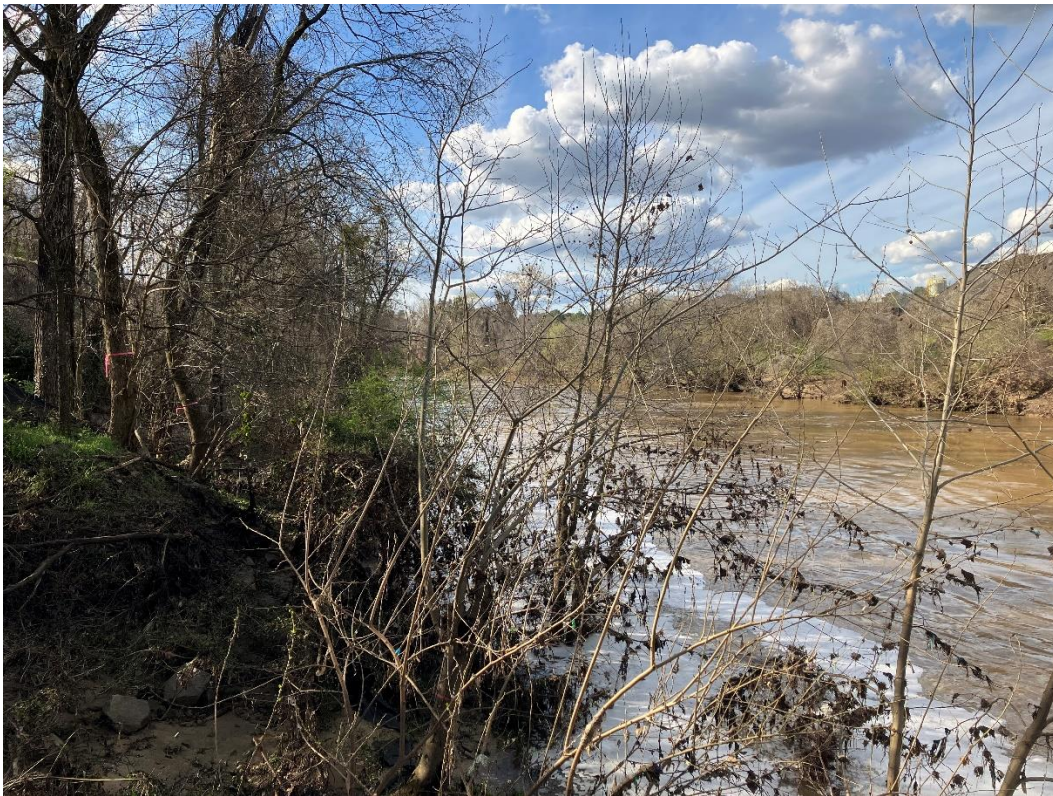
Effluent Discharge Photo 3: Effluent Traveling Downstream of the Chattahoochee River (2)

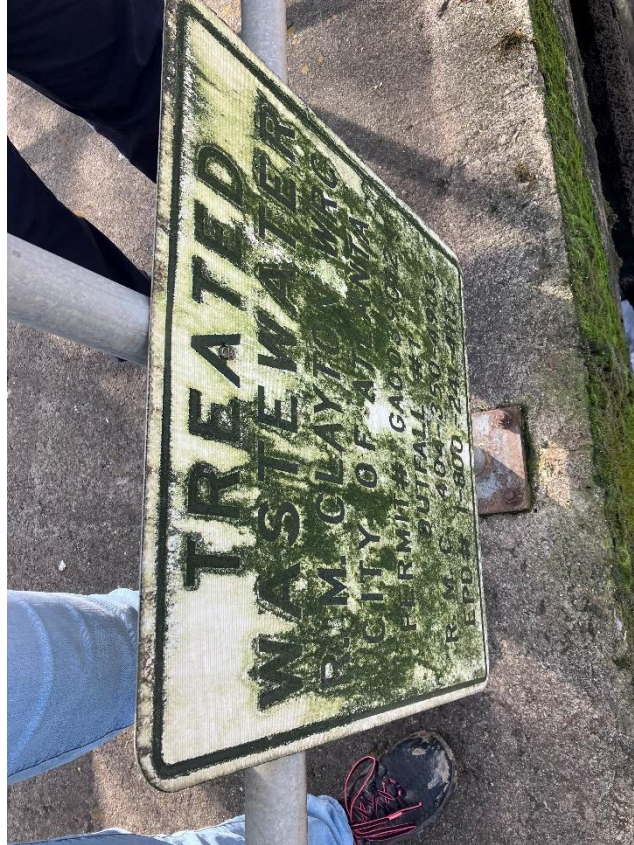
Effluent Discharge Photo 4: Outfall Identification Sign

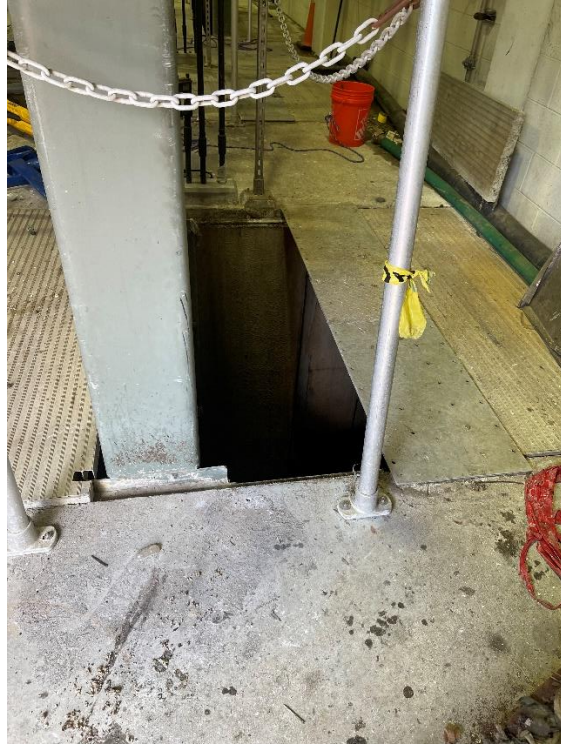
There is a chain surrounding one of the bar screens around an open area. However, the chain is not sufficient to protect plant staff from falling into the open space.

O&M Photo 1: Open Space on the Bar Screen

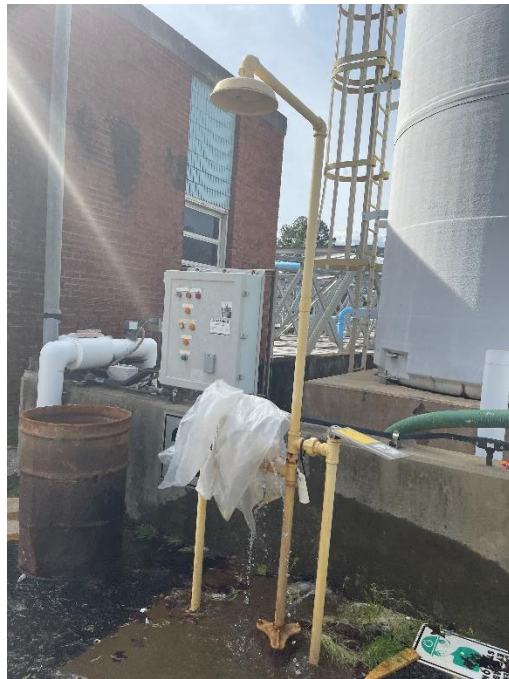
The eye wash station near the primary clarifiers was leaking water. EPD was informed that a new station had been ordered to replace the leaking one, but the station had been leaking water since at least November 2023.

O&M Photo 2: Broken Eyewash Station (1)

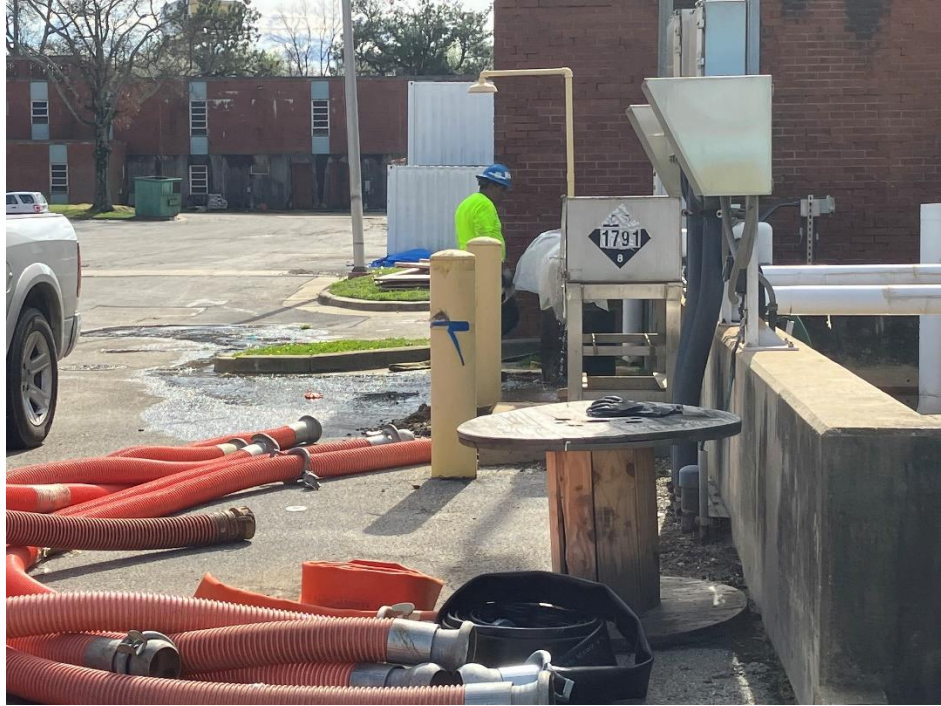
O&M Photo 3: Broken Eyewash Station (2)

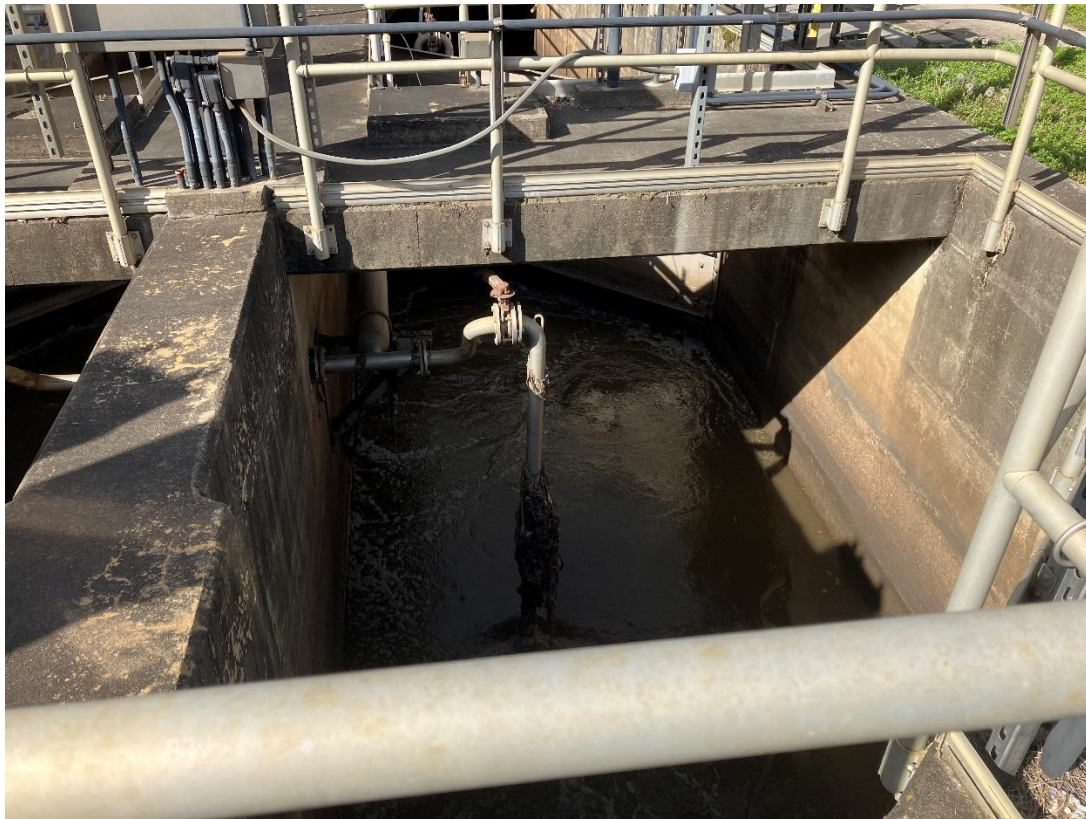
EPD was informed that mixed liquor wells are to receive maintenance once a year, but they had not been cleaned out to remove debris in a couple of years. There is a PM for the cleaning, but there is not an associated date.

O&M Photo 4: Mixed Liquor Wells (1)

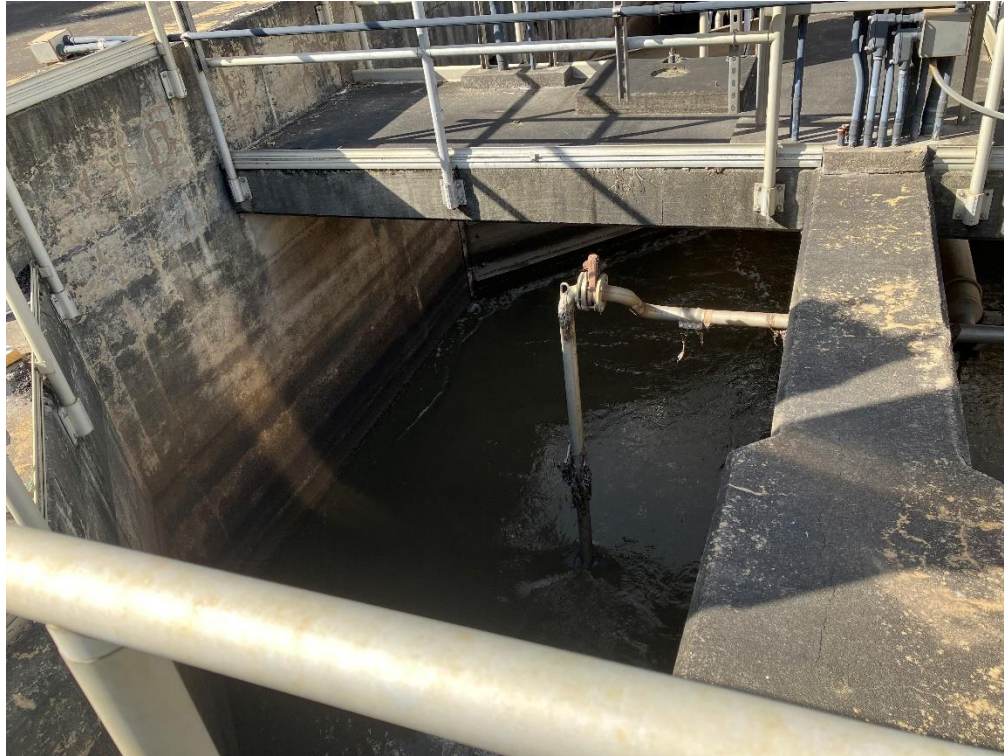
O&M Photo 5: Mixed Liquor Wells (2)
