Facility Inspection
City of Atlanta- R.M. Clayton WRC
NDPES Permit No. GA0039012

City of Atlanta R.M. Clayton WRC Inspection Report

Re: NPDES Permit No. GA0039012, Reconnaissance Inspection Report

United States Environmental Protection Agency
Region 4
Reconnaissance Inspection Report
Project No. CV-RI-GA0039012-08082024

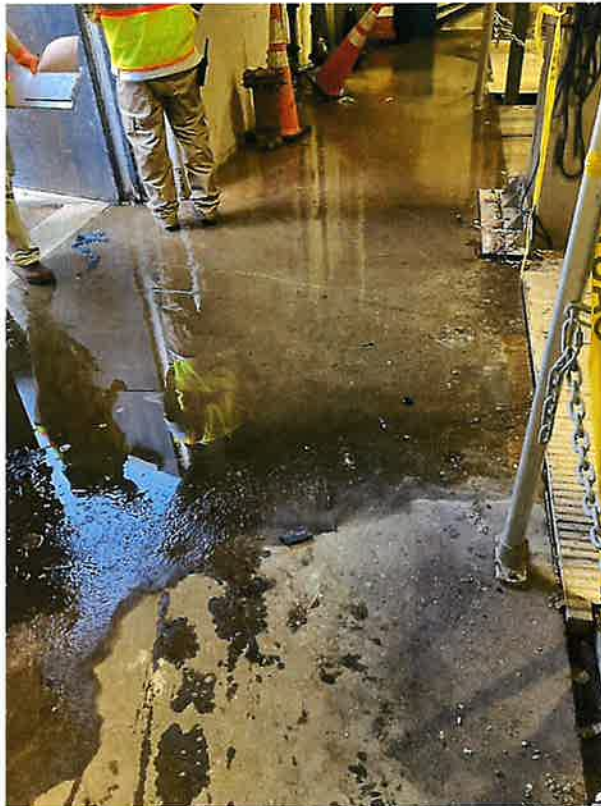
There were multiple maintenance issues identified. In the bar screen room, there is a broken spigot spraying water onto the floor, resulting in ponding and potable water on the floor throughout the room. Inspectors were informed that the leak had been occurring for about a month. To repair the line, the water to entire area must be shut off. A request has been placed with facility maintenance, with a repair date pending.

Photo 2: Leak in Bar Screen Room

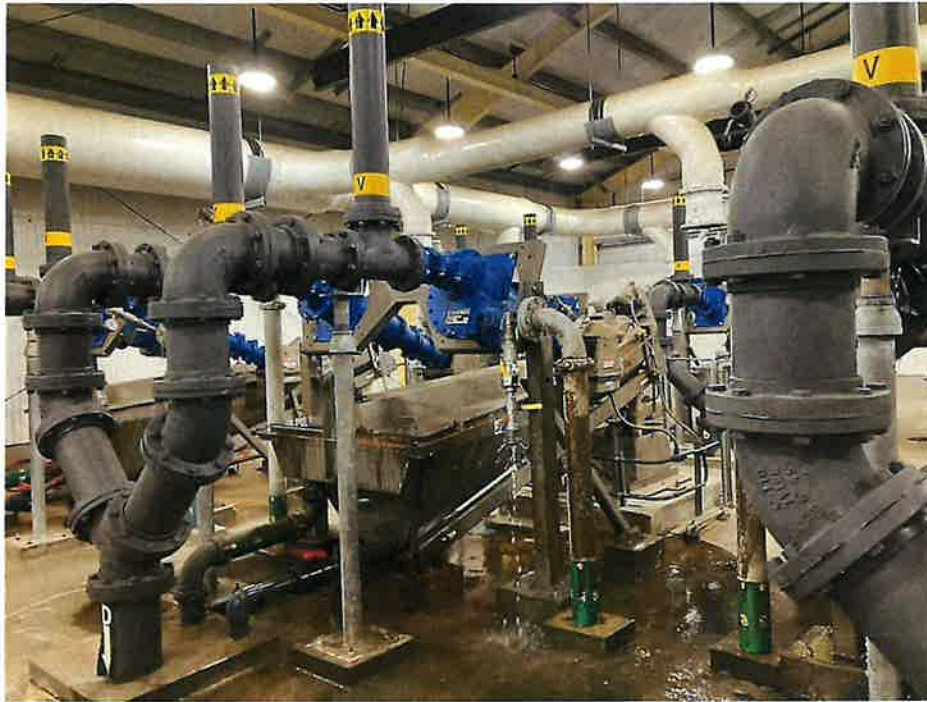
The WRC has 12 grit cells and classifiers. The inspectors noted damage to grit classifiers #1 and #4. Inspectors were informed that classifier #1 went out-of-service the previous day and a work order has been entered for the repair.

Photo 5: Damaged Grit Classifier (1)

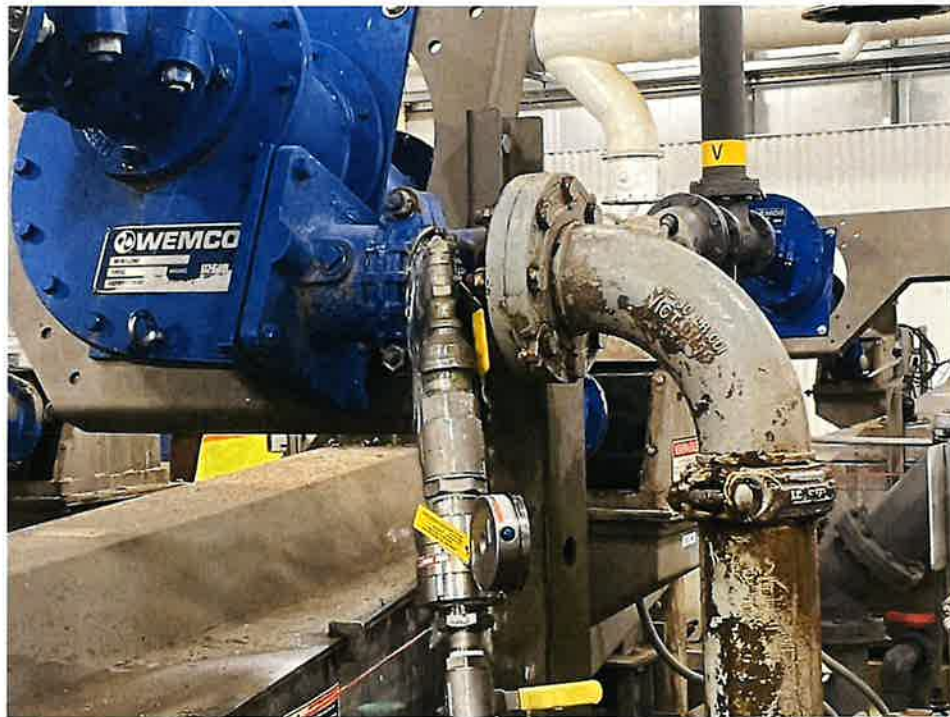
Photo 6: Damaged Grit Classifier Zoomed In

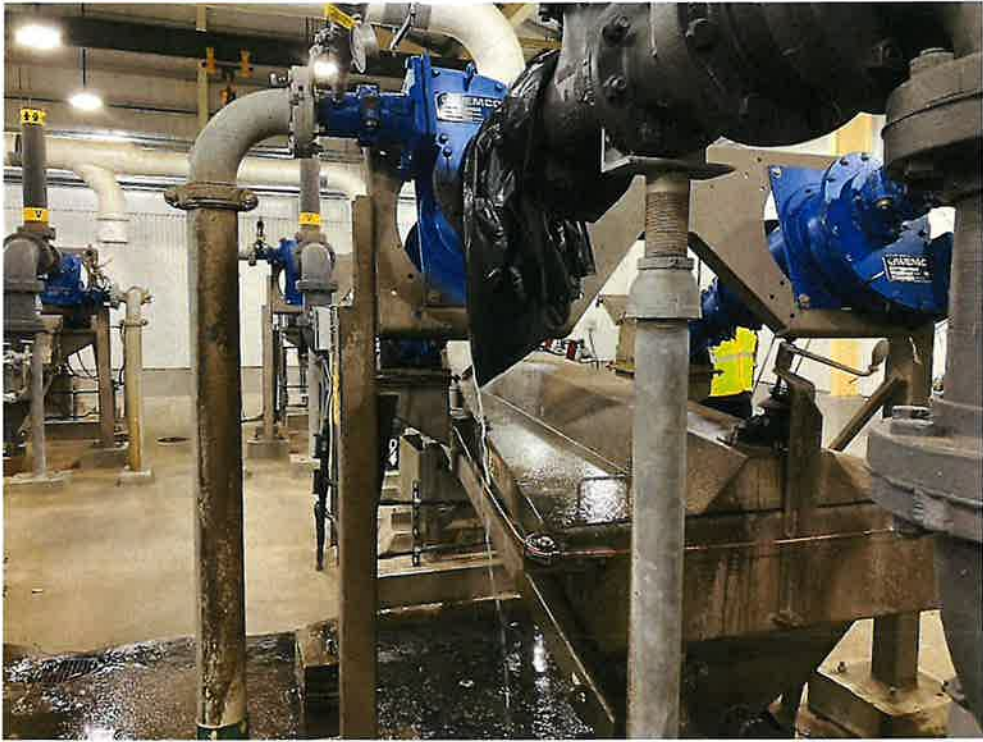
Photo 7: Damaged Grit Classifier (2)

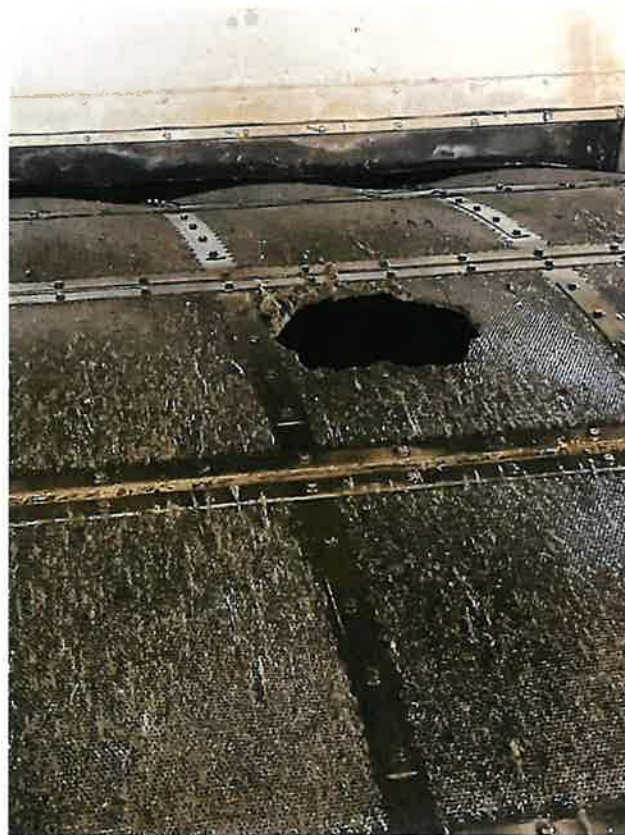
The WRC has four bar screens. All bar screens are operable as designed. Bar screens are used based on the facility flow. The WRC has three drum screens. All three screens can be operated. Drum Screen #2 has a hole in the screening, but it can be operated to assist in reducing debris. Inspector were informed that the damage had been present for approximately two weeks and drum screen #2 is only operated during high flows. Inspectors were also informed that the replacement screen has been received and the facility is awaiting replacement.

Photo 10: Damage to Drum Screen #2

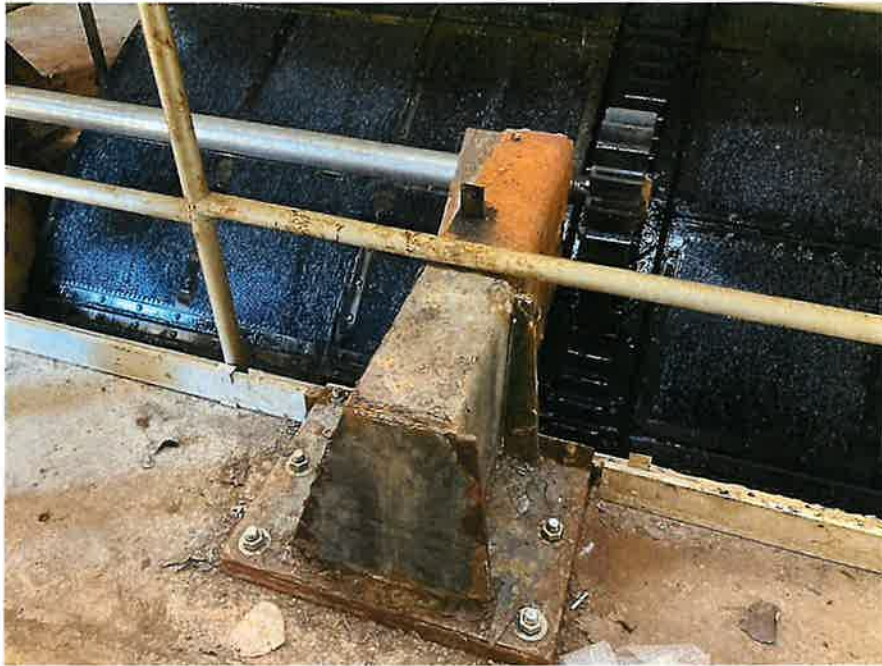
Facility personnel turned on drum screen #2 to demonstrate operation ability. The motor drive cover for screen #2 is rusted and shakes some when the drum screen is in operation.

Photo 11: Motor Cover for Drum Screen #2

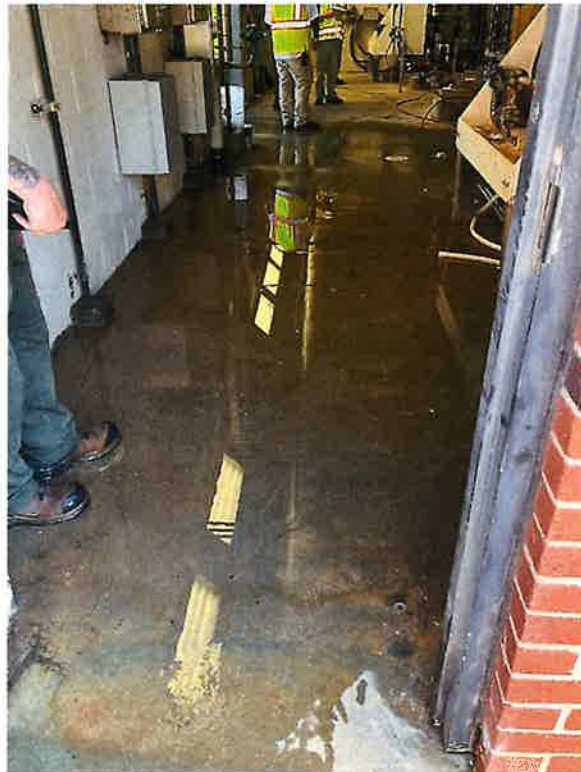
The grit classifiers requiring repairs are leaking water onto the floor in the room. The eyewash/shower station in the old chemical room ponds on the floor instead of flowing to the associated drain. There was potable water leaking at various parts of the facility.

Photo 12: Water from Eyewash/Shower in Old Chemical Building

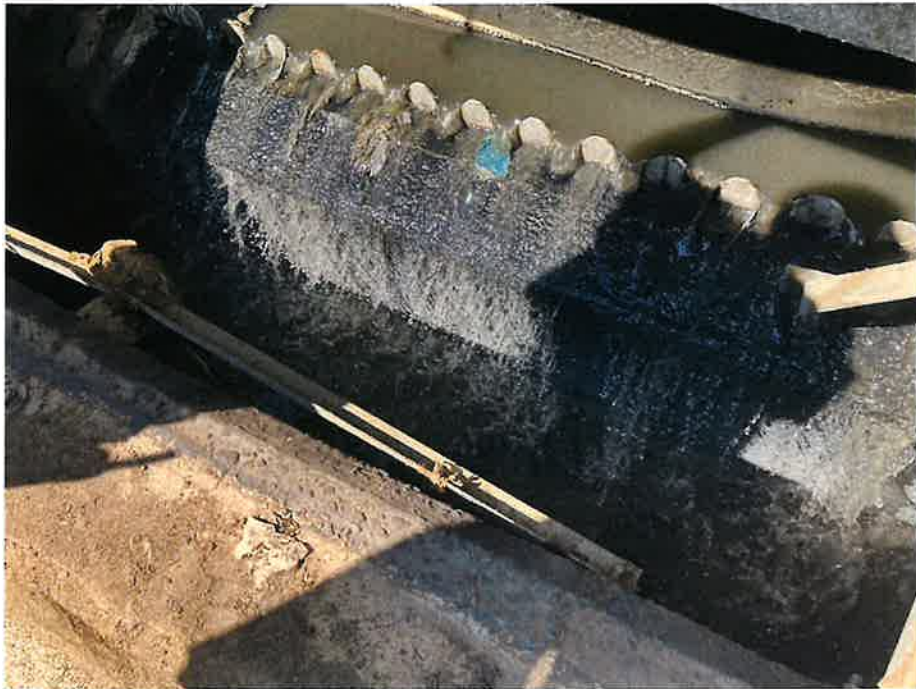
The inspectors viewed each of the eight primary clarifiers through a bay opened by plant personnel. All eight clarifiers were operational with flow over the weirs. Debris and algae were observed in the weirs of all eight clarifiers. EPD was informed that a preventative maintenance (PM) is underway for either weekly or bi-weekly cleanout of the weirs. A sludge judge was used to measure the sludge blanket of primary clarifier #6. Then blanket was 4.5 feet.

Photo 14: Primary Clarifier Weir (1)

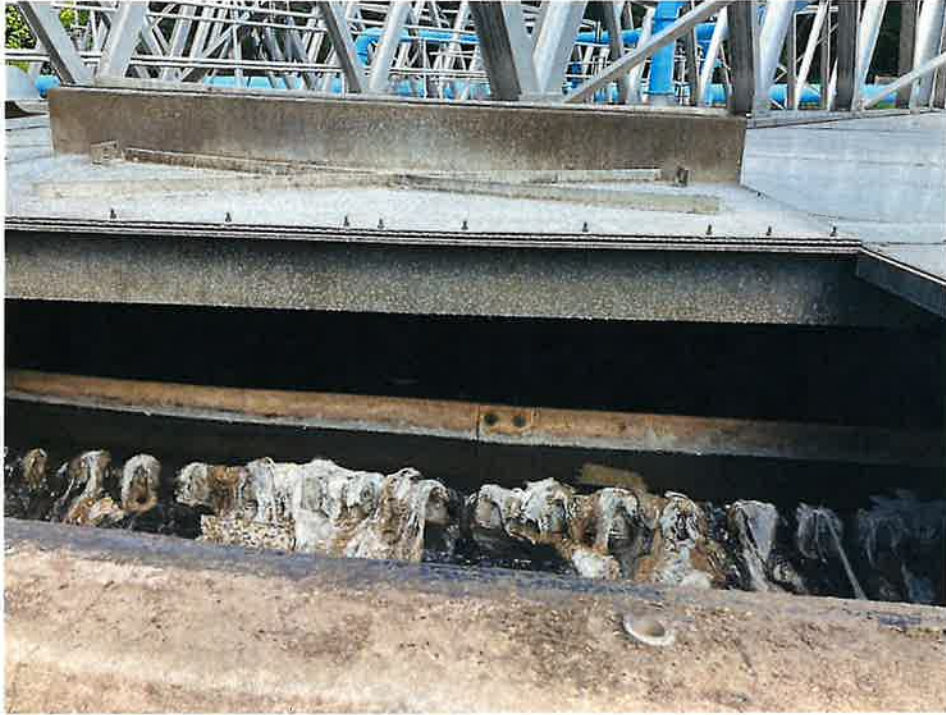
Photo 15: Primary Clarifier Weir (2)

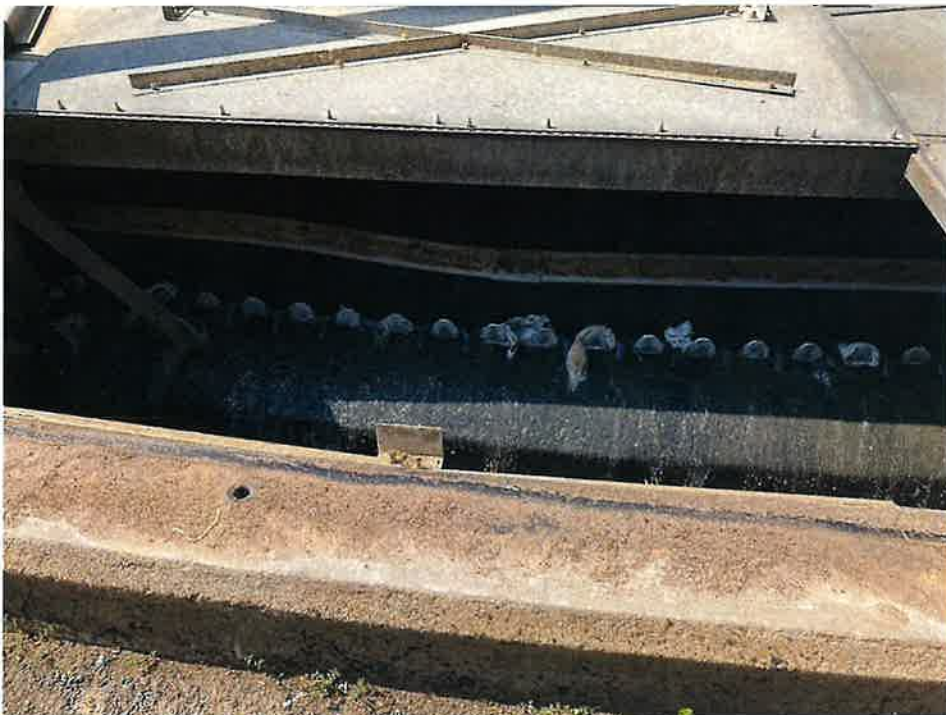
Photo 16: Primary Clarifier Weir (3)

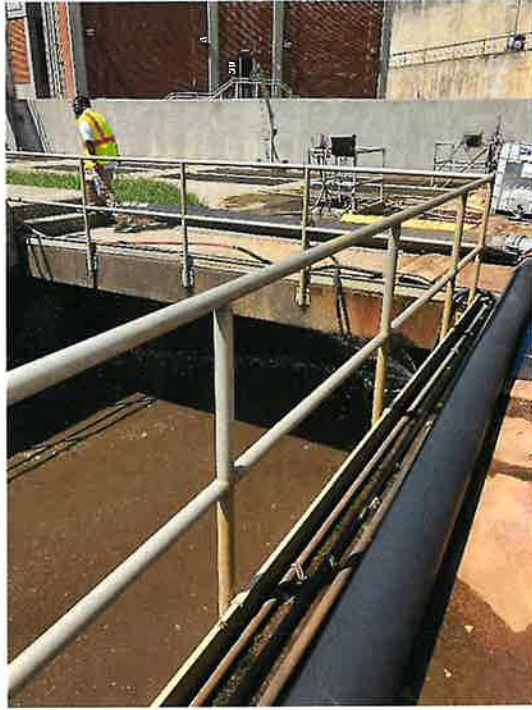
Photo 19: Potable Water Leak in BNR Basins

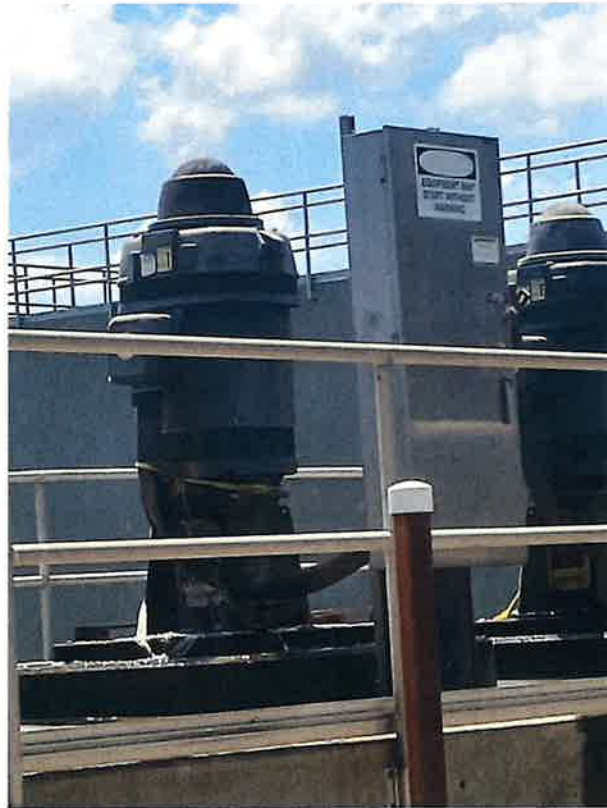
Photo 36: Damaged Equipment Near UV

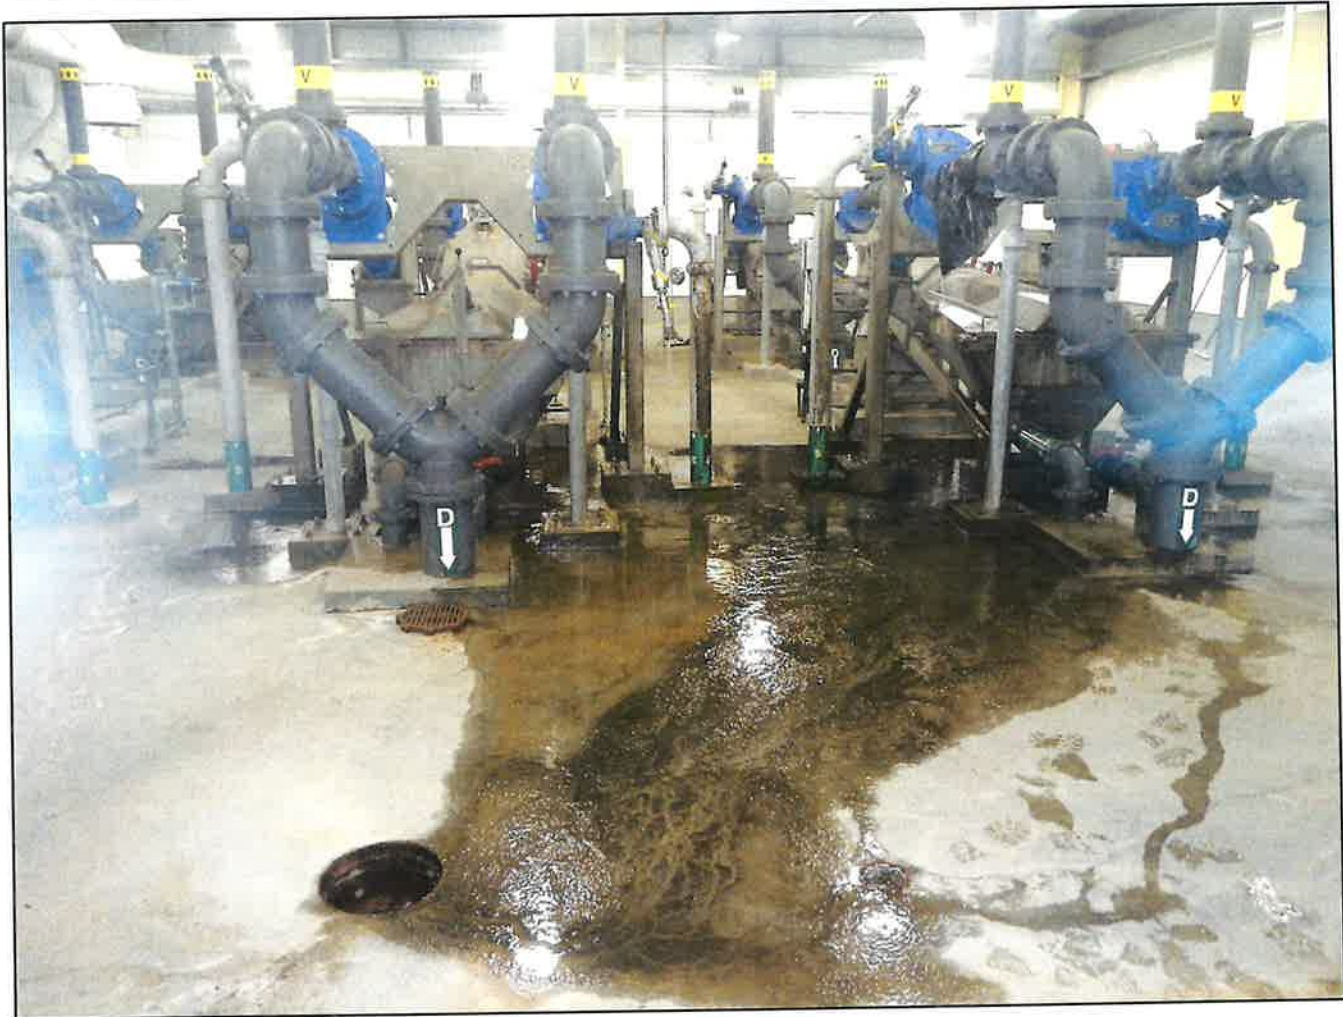
Mr. Jenkins joined the inspection beginning at the grit management equipment building. This building had an odor control system in place that was operating. The lower floor contained two truck trailers that were collecting the grit separated from the wastestream by the six vortex collection systems located on the upper floor. Each vortex unit has two collection cells, and the units cycle on based on flow demand. On the upper floor, inspectors encountered another collection of water on the floor that EPA sourced to leaks from classifier cell #4 of vortex unit #2, and classifier cell #1 of vortex unit #1.

Photo 1. Primary Screening - Leaks from equipment seals on second floor of Grit Management Building; pictured are vortex separator Unit #1, classifier cell #1 and Unit 2, classifier cell #4.

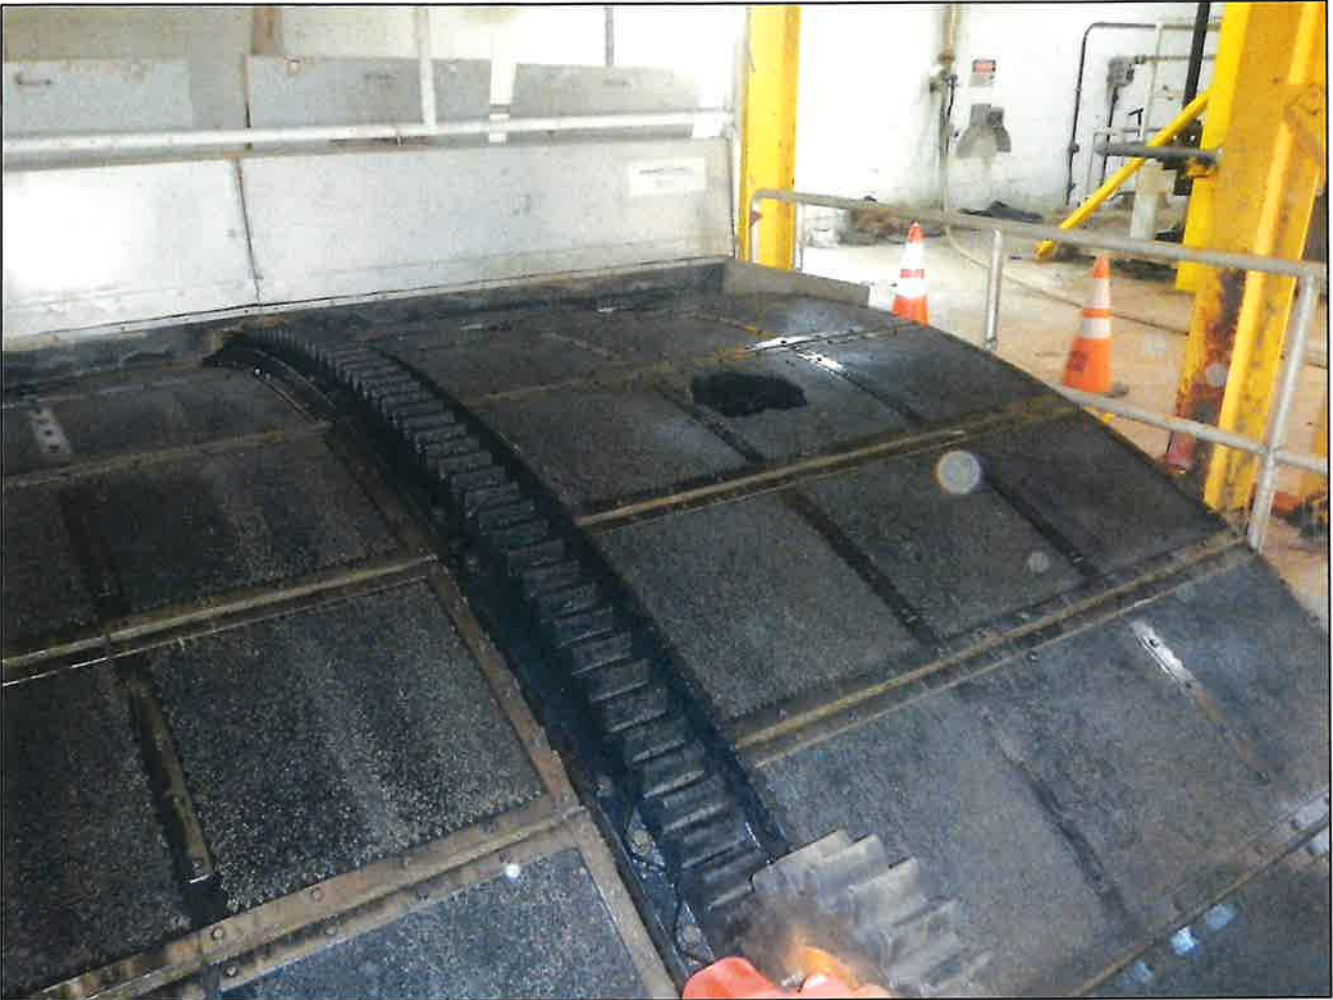
The drum screen building, which houses the three large rotating drums with perforated screens was evaluated. Inspectors observed that all three drums were operational, but drum #2 had a screen element with an estimated 1 to 1.5 foot diameter hole in it. Deputy Commissioner Fletcher noted that drums #1 and #3 were normally used, and #2 was only deployed in high flow situations. Later, during the closing, Mr. Porter noted that a replacement screen had been received from the overseas manufacturer and it was available to install, but the work order he submitted two weeks ago was still outstanding.

Photo 2. Primary Screening – Hole within fine mesh screen drum #2 in Drum Screen Building.

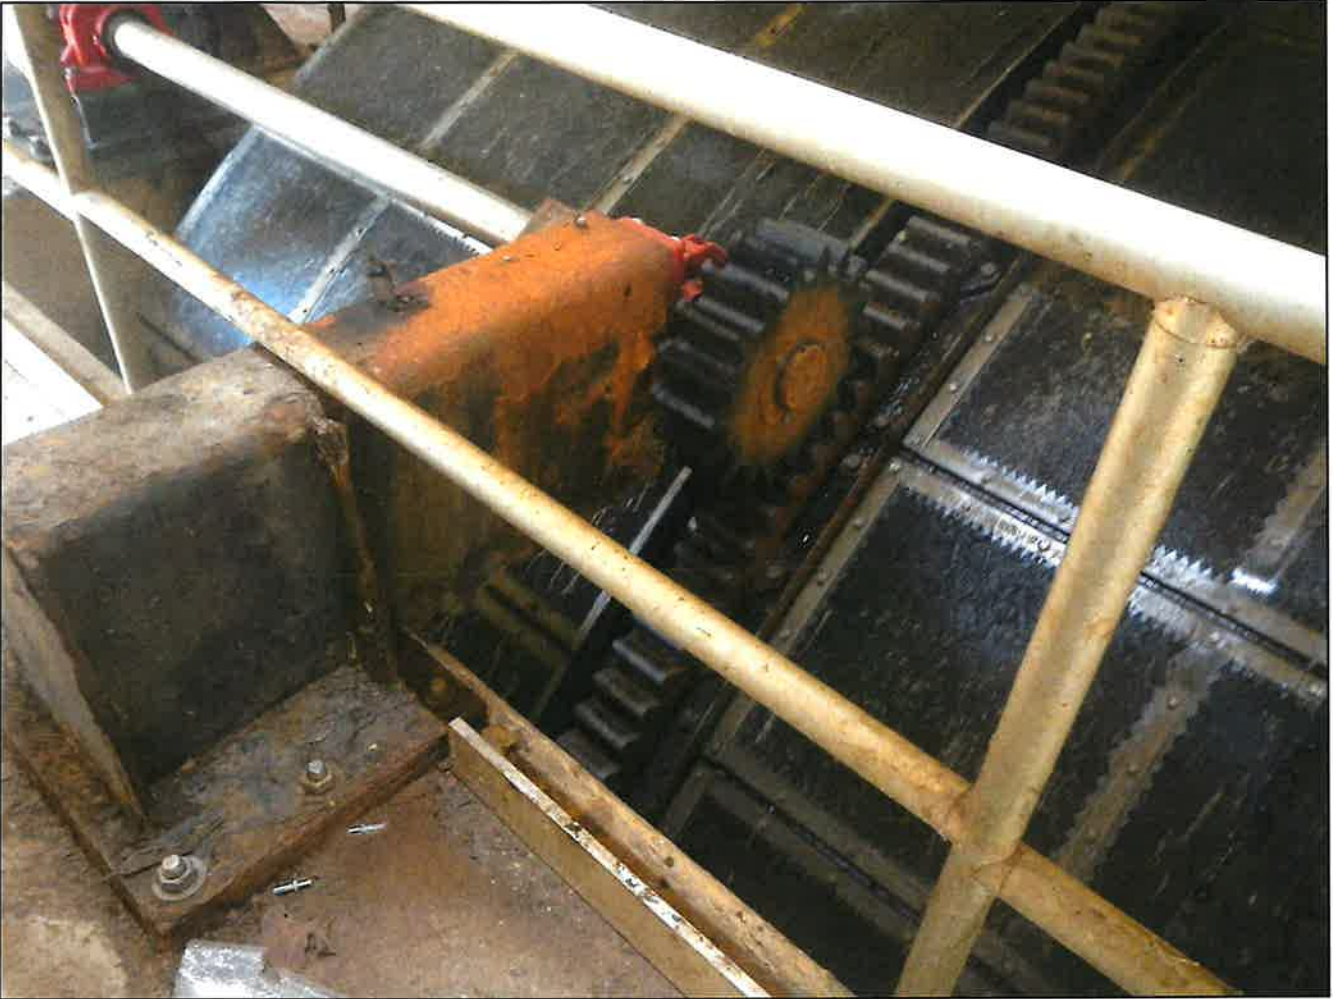
The motor drive cover and drive base for drum #2 were also significantly rusted compared to

those for the other two drums. Deputy Commissioner Fletcher noted they would look into replacing those.

Photo 3. Primary Screening – Rusted drive cover of fine mesh screen drum #2 in Drum Screen Building.

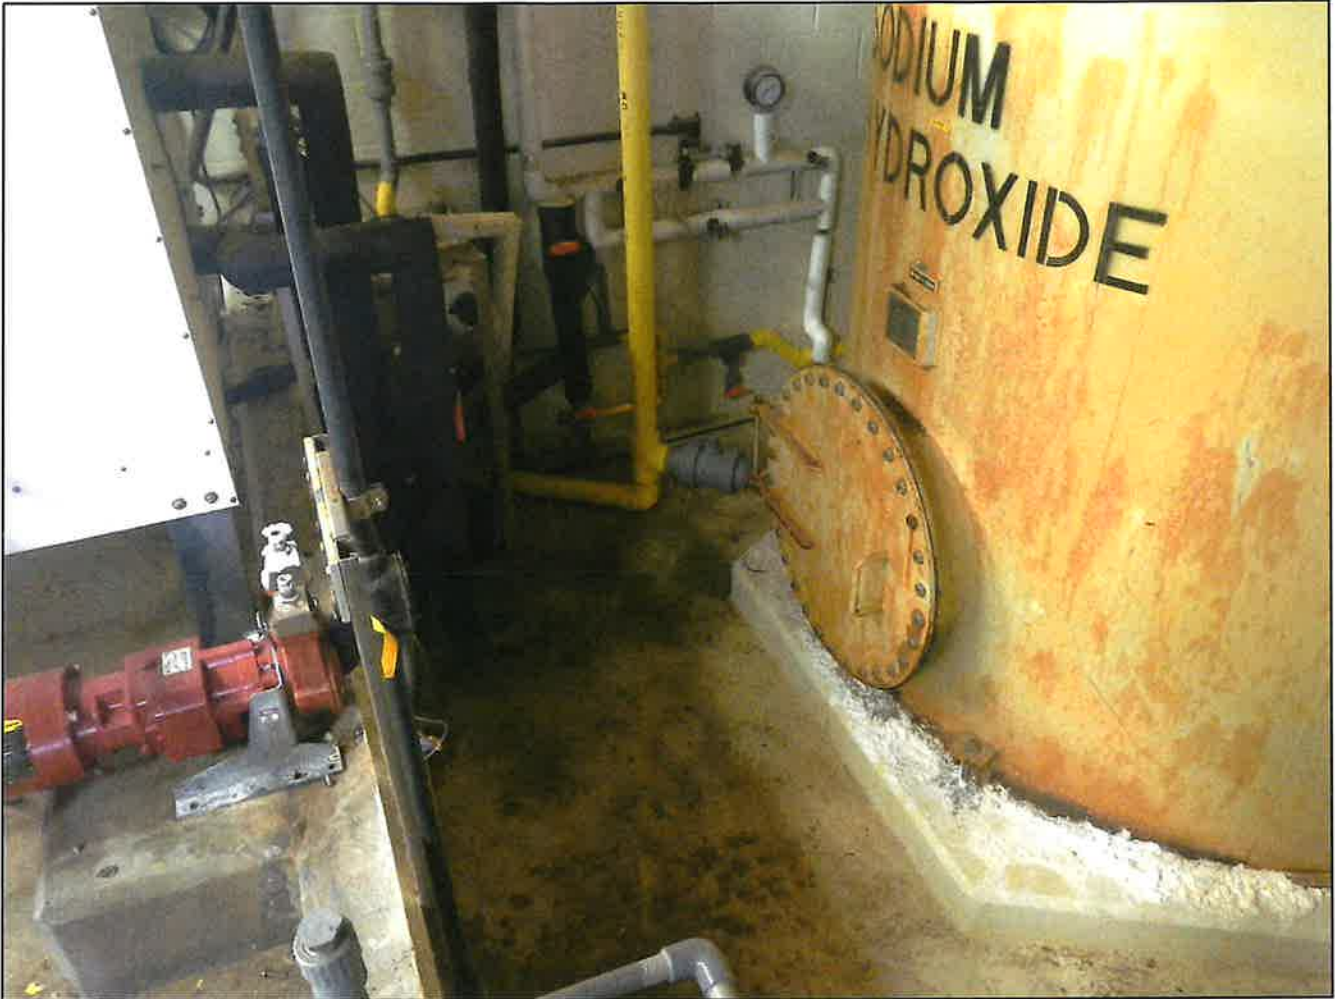
- b. *Chemical storage.* The inspection team stopped at chemical storage area #1791 in Headworks Building #32. When the Safety Officer tested the eye wash station, water ponded in the building rather than to an eye wash drain. Mr. Turner noted this chemical storage area serves as a secondary supply of sodium hypochlorite to be used in the event of high demand. EPA inspectors observed a pair of large chemical storage tanks in the area labeled as sodium hypochlorite and 10 CST 1. EPA inspectors observed liquid in the secondary containment pit, and the pumps associated with the tank had white corrosive build-up present suggesting they may have difficulty functioning if called upon. EPA inspectors did not observe an emergency ventilation system and an alarm in the event of a tank leak.

Photo 4. Chemical Storage – Corroded sodium hypochlorite tank base, corroded delivery device, and leakage in secondary containment.

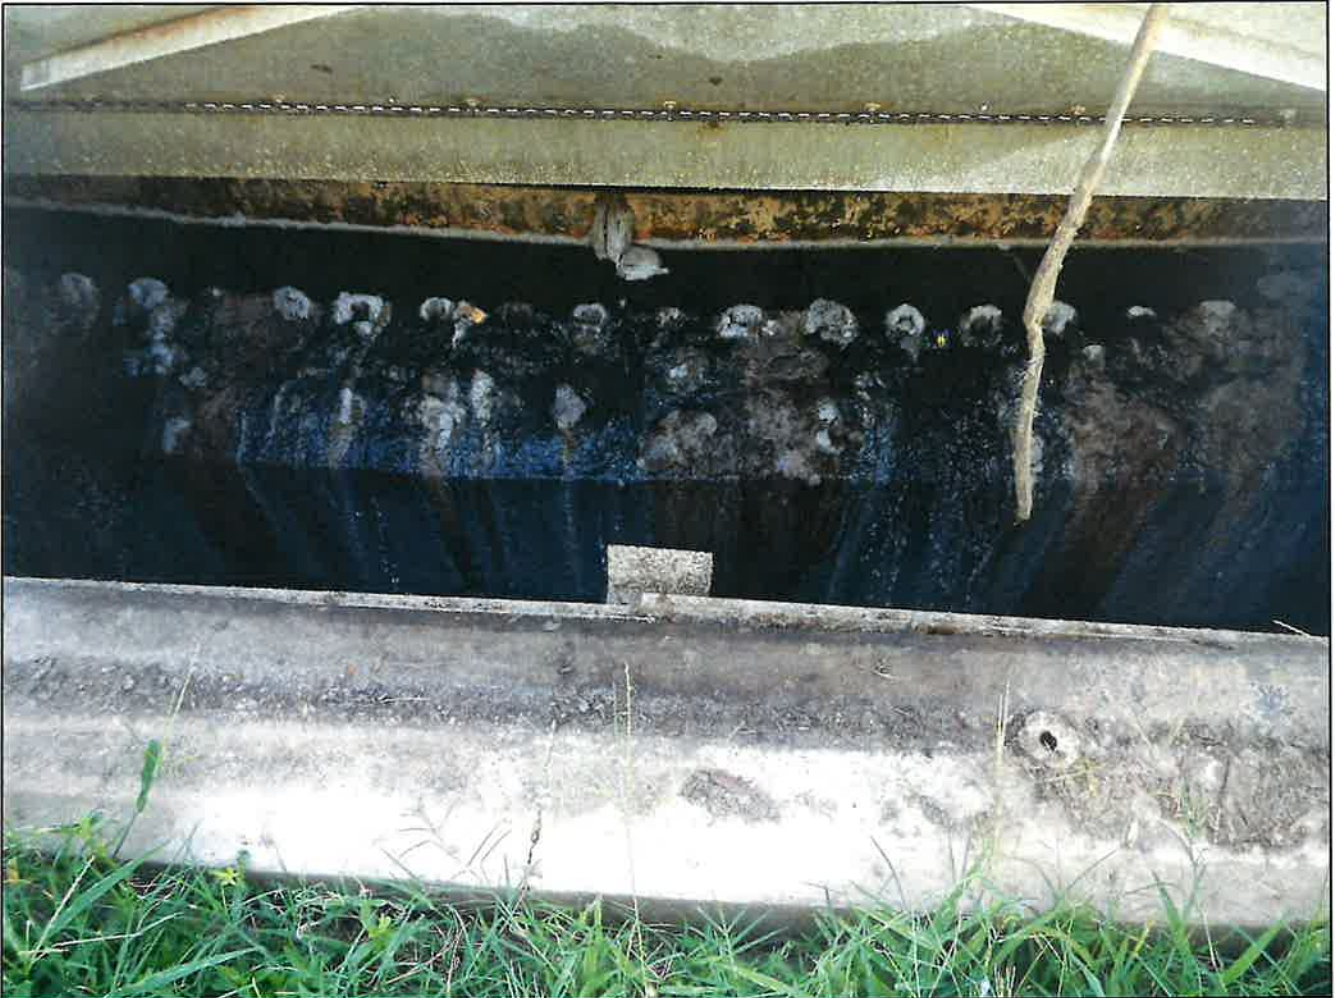
All eight of the primary clarifiers were operating and flows over the weirs were observed. Primary clarifier #5 was not flowing but was operationally gated and Mr. Turner opened the gate temporarily to demonstrate flow. All eight of the primary clarifiers were observed to have unscreened debris and algal build-up on their weirs, indicating operational and maintenance needs. Georgia EPD requested the blanket depth of primary clarifier #6 be measured with a field tube, also known as a sludge judge. The blanket depth in the well 4.5 feet.

Photo 5. Primary Clarification – Debris and algal buildup on weirs, and evidence of solids passage over weirs; pictured is primary clarifier #8.

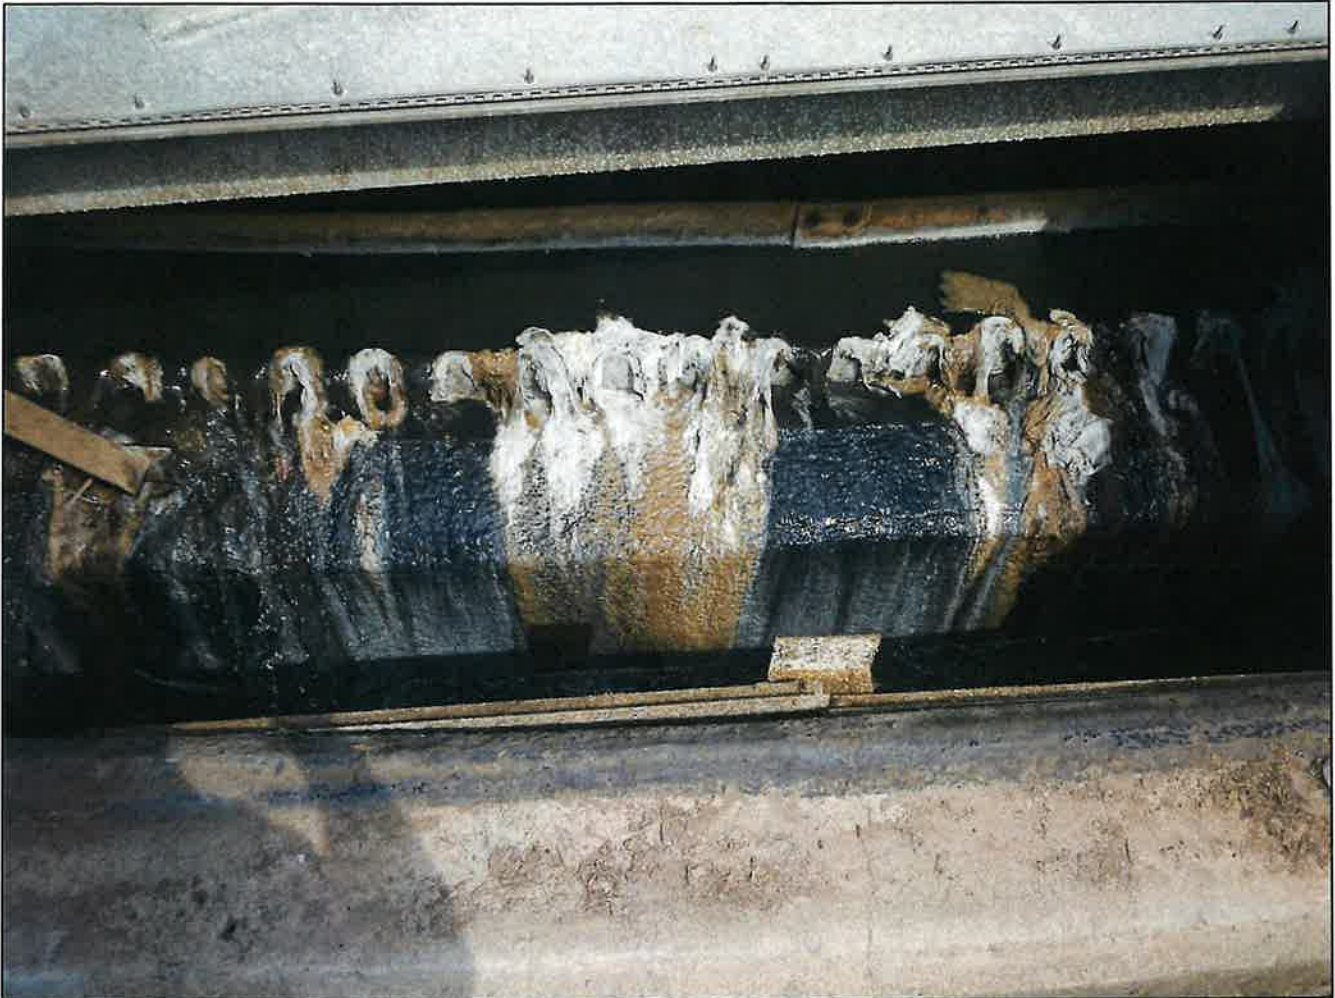
Photo 6. Primary Clarification – Debris and algal buildup on weirs, and evidence of solids passage over weirs; pictured is primary clarifier #4.

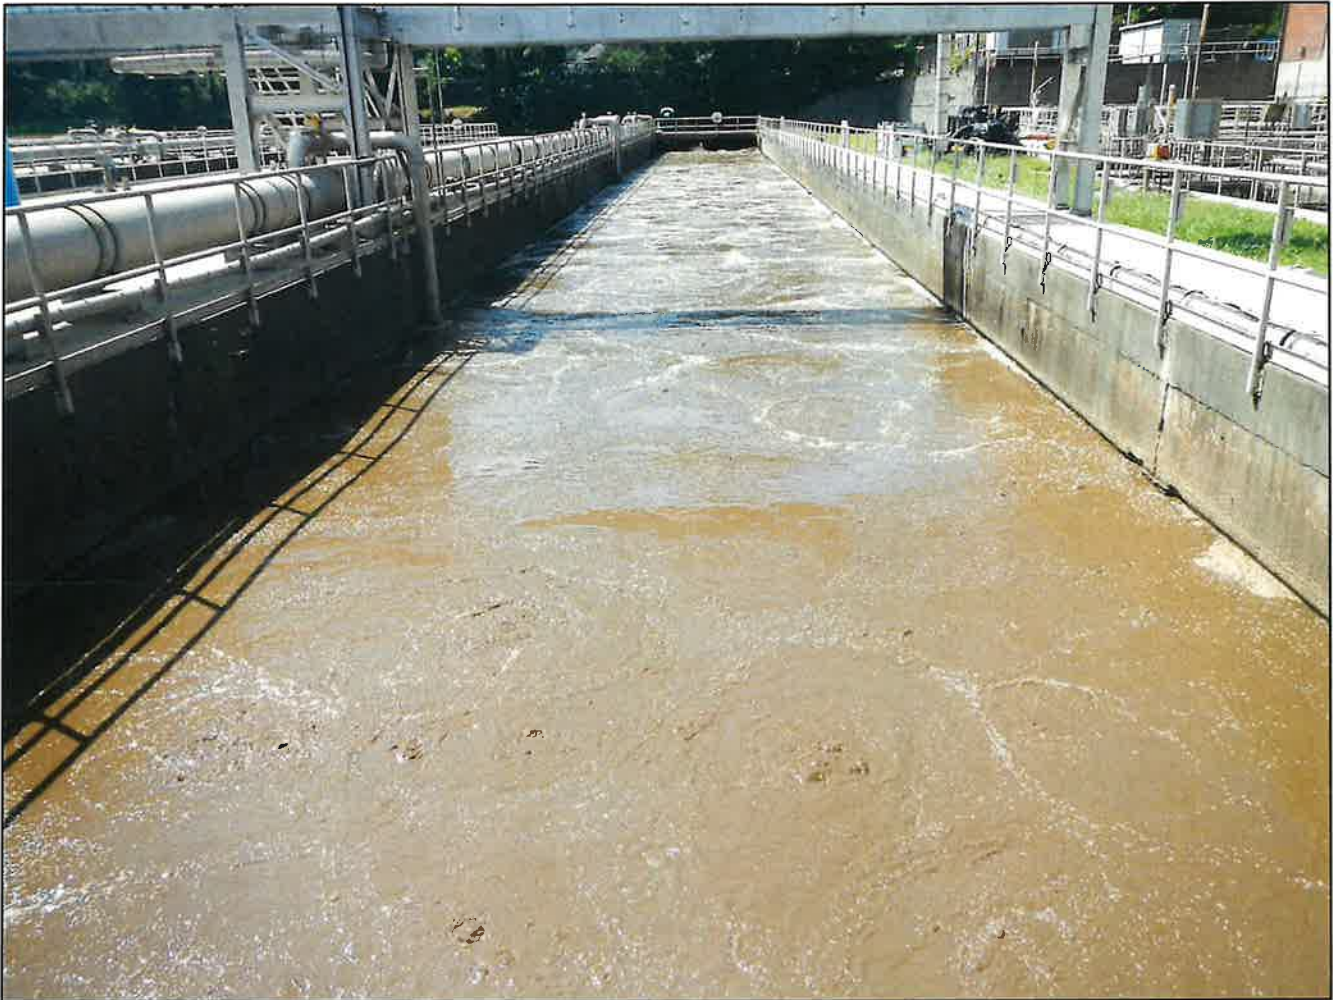
- d. *Aeration / Biological Nutrient Removal ("BNR") Tanks.* The 14 BNR tanks were inspected. The Facility management advised of ongoing maintenance activities on broken diffusers and air supply lines to these tanks. Broken diffusers observed in BNR #9 and broken diffusers and air supply lines observed in BNR #14 were stated to be under an active repair contract and would be returned to service the next day. Facility management noted that similar issues observed with BNRs #3 and #11 are next to be contracted. EPA inspectors also observed BNR #1 to have diffuser issues and observed unscreened floating debris that had passed into BNR #12 and #13.
- e. *Mixed Liquor Pump Station Well.* The BNR trains are separated by a hill, and mixed liquor is

Photo 7. Biological Nutrient Removal (“BNR”) – Evidence of diffuser issues in Tank #1.

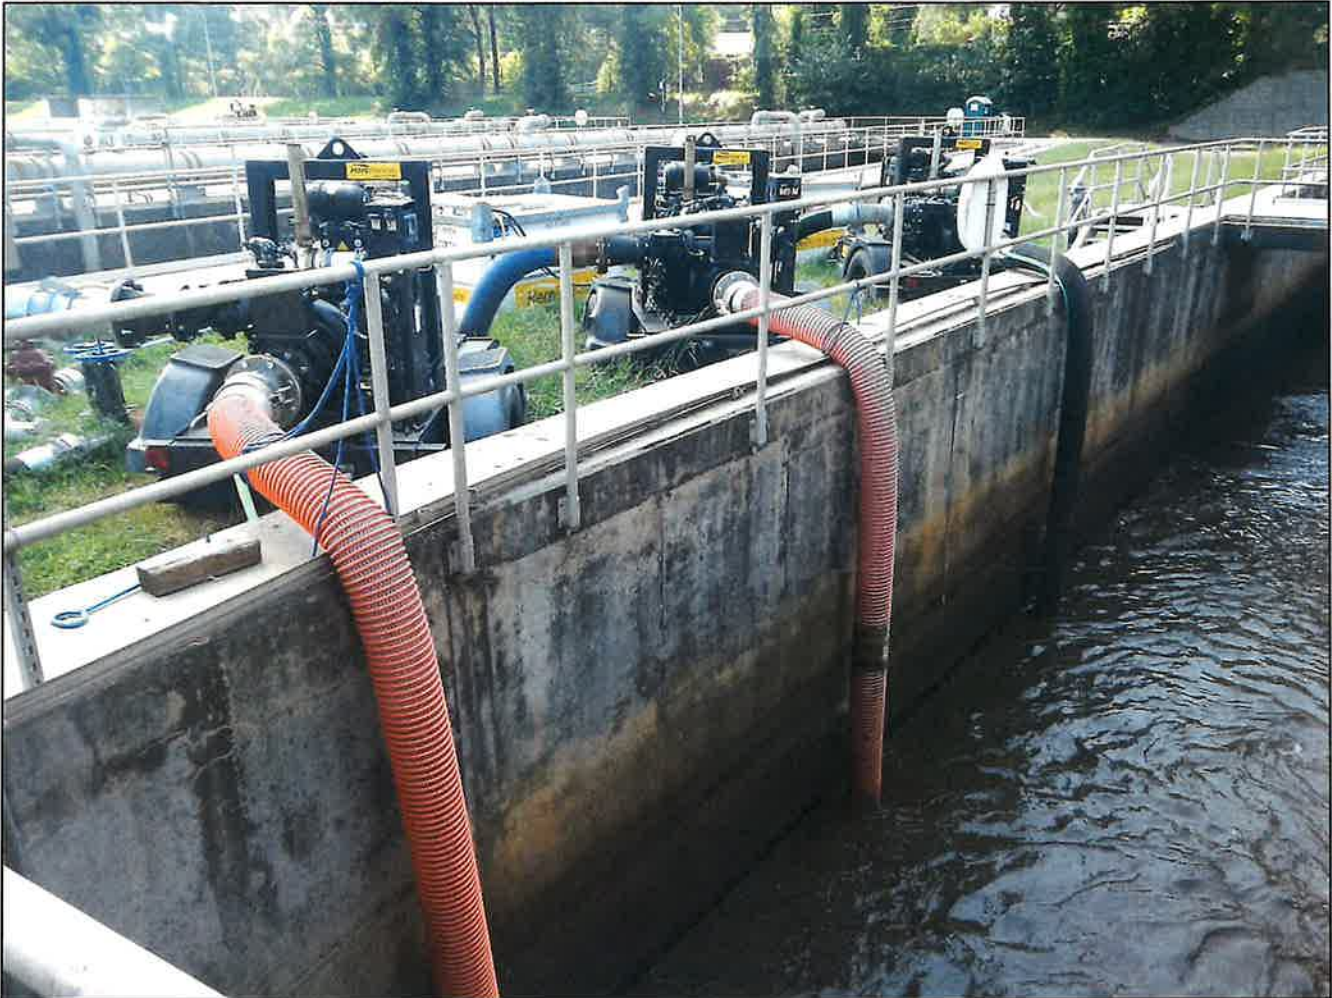
pumped up the hill to the train including BNR #11 through #14. EPA inspectors noted the presence of three rental pumps setup to draw from the well catchment. Mr. Turner advised that two of the six pumps at the Facility designed for this purpose were slated for repair. Mr. Porter later noted that one of the four waste return pumps was also down for maintenance.

Photo 8. Mixed Liquor Pump Station Well – Bypass pumps in place.

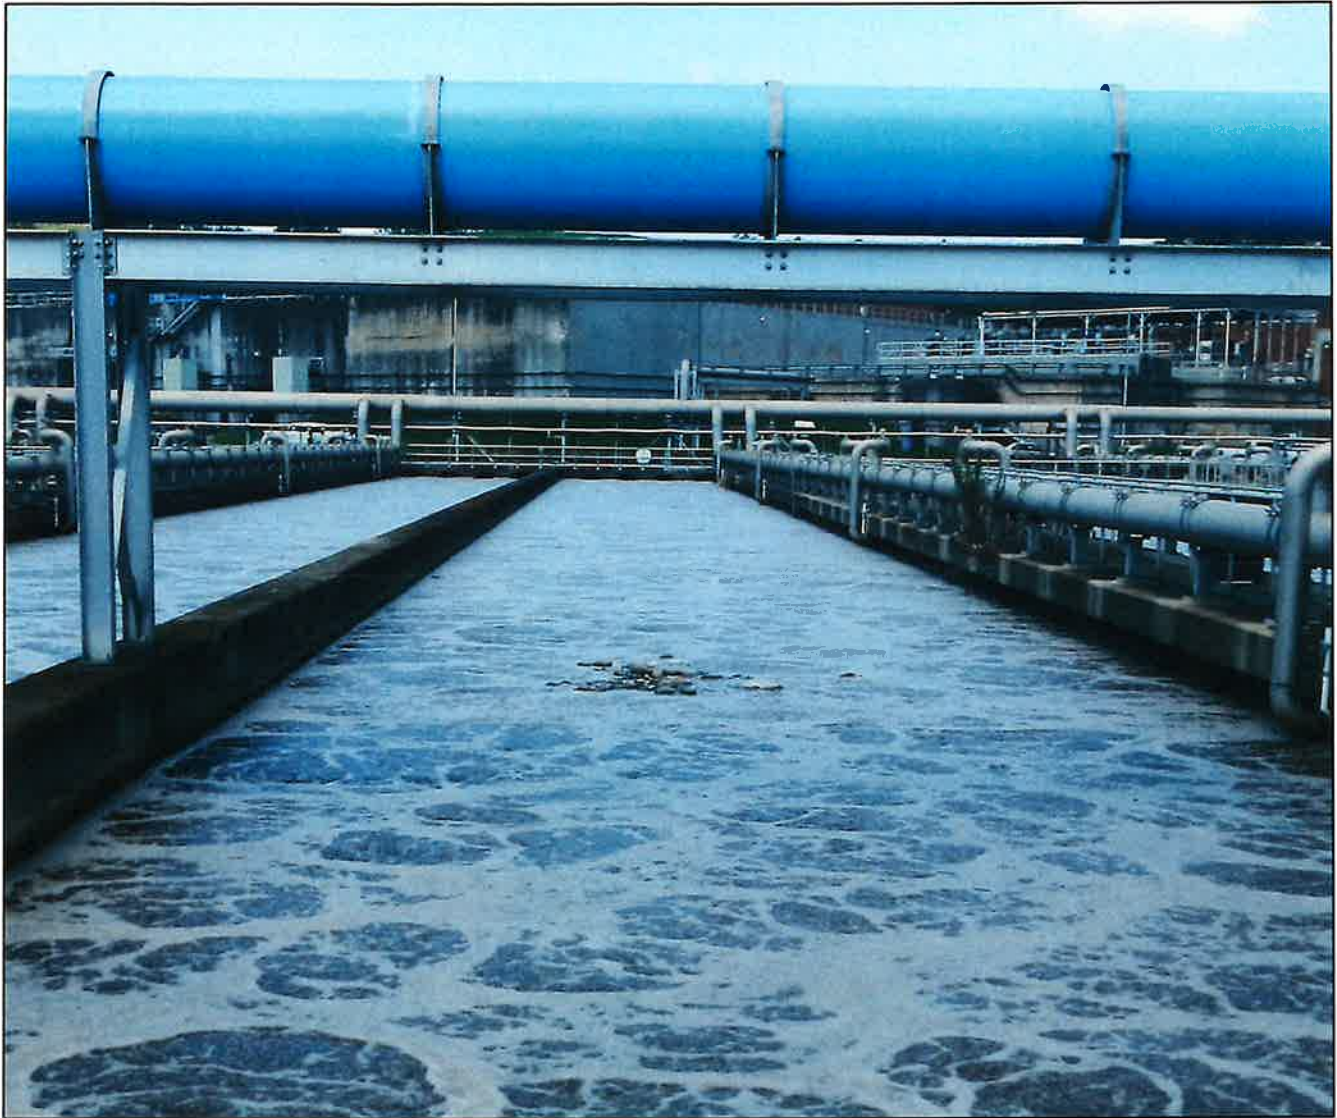
Photo 9. Biological Nutrient Removal (“BNR”) – Floating unscreened solids in BNR Tank #13.

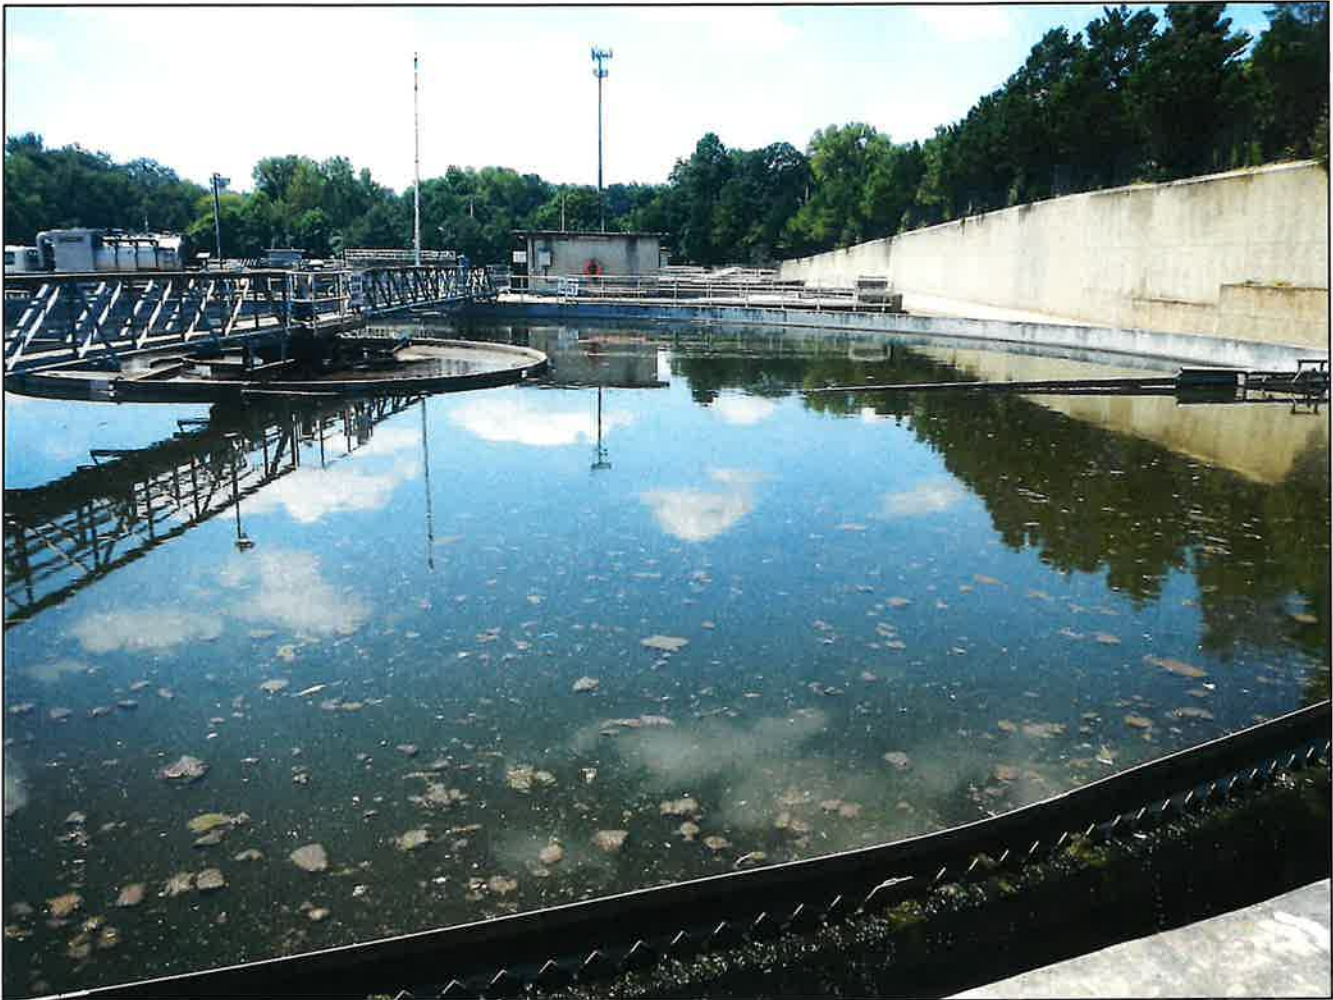
Skimming arms in several units were broken or bent. Unit number 2 was bent, unit number 5 was completely broken in half, and unit number 7 was also broken.

Photo 11. Secondary Clarification – Clarifier #7 with abundant floating solids and broken skimming arm.
