Facility Inspection
City of Atlanta- R.M. Clayton WRC
NDPES Permit No. GA0039012

City of Atlanta R.M. Clayton WRC Inspection Report

Re: NPDES Permit No. GA0039012, Reconnaissance Inspection Report

United States Environmental Protection Agency
Region 4
Reconnaissance Inspection Report
Project No. CV-RI-GA0039012-08082024

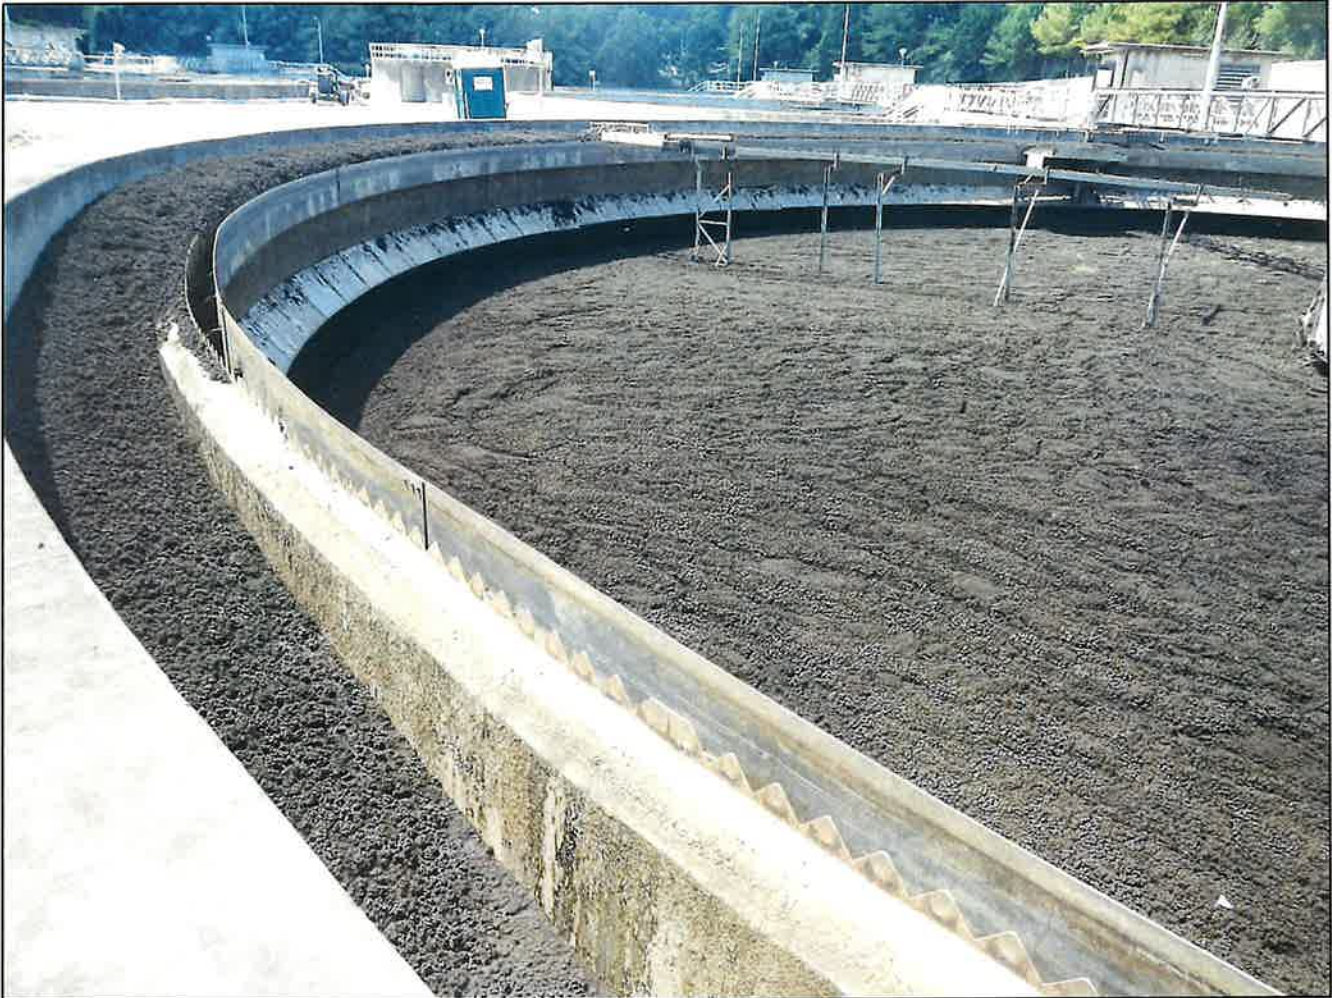
Skimming arms in several units were broken or bent. Unit number 2 was bent, unit number 5 was completely broken in half, and unit number 7 was also broken.

Photo 12. Secondary Clarification – Clarifier #5 (out of service) drained with evidence of solids blanket floatation that had extended beyond the outer weir into the effluent channel.

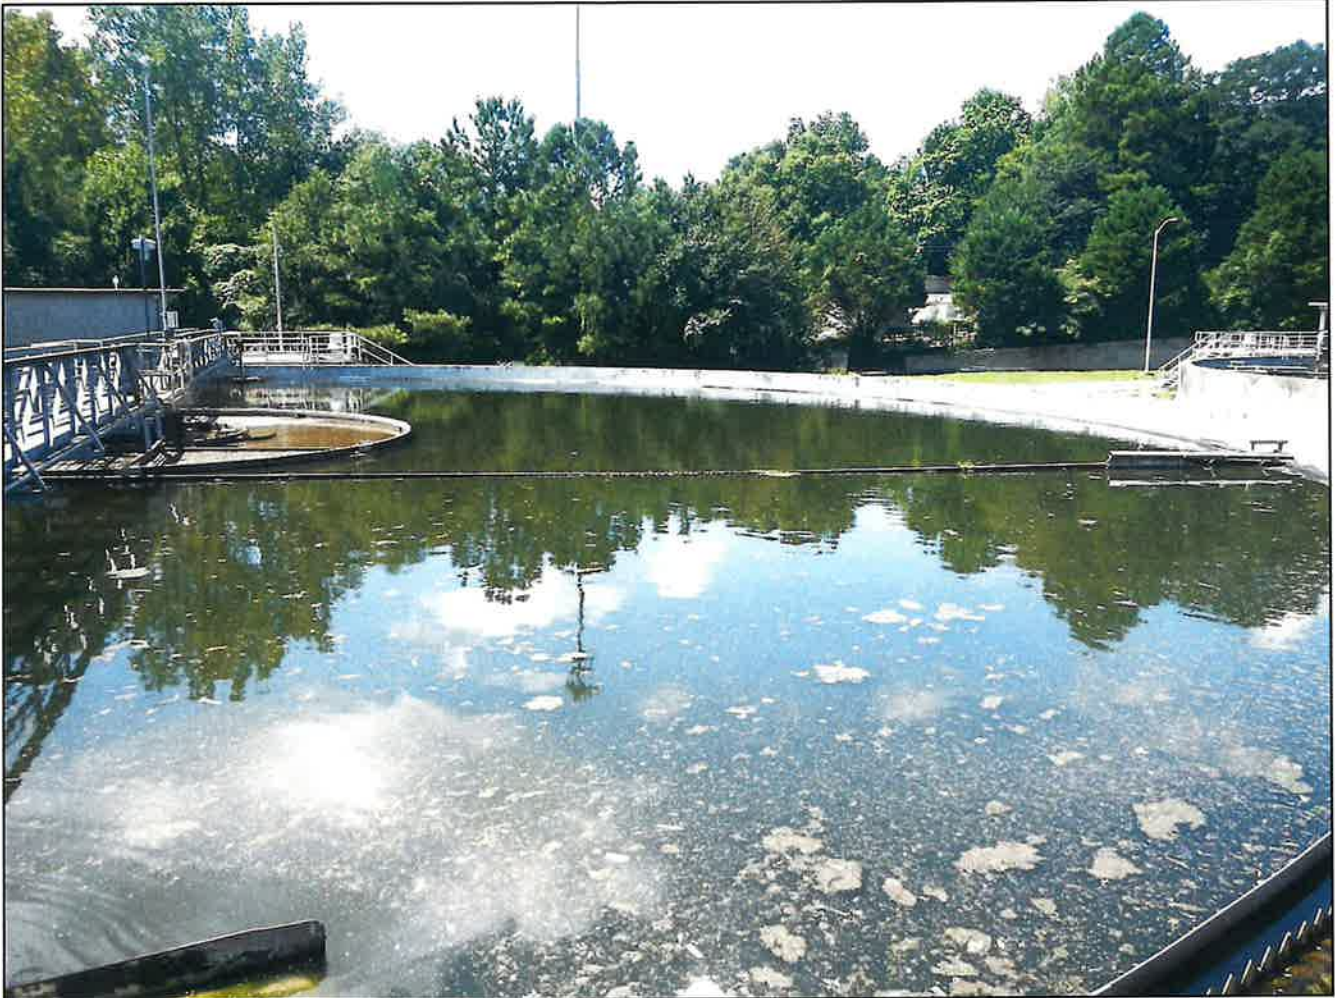
All secondary clarifiers had evidence of a lengthy operational problem, which was observed as floating solids ranging from pin floc (unit numbers 1, 3, and 4) to more significant quantities of large floating solids (unit numbers 2, 6, 7, and 9). In most of these units, the floating solids were observed passing through the weirs as they broke up. The aluminum staircase at unit number 2 was in disrepair, appearing to have been hit by a motorized vehicle.

Photo 13. Secondary Clarification – Clarifier #2 with abundant floating solids and bent skimming equipment.

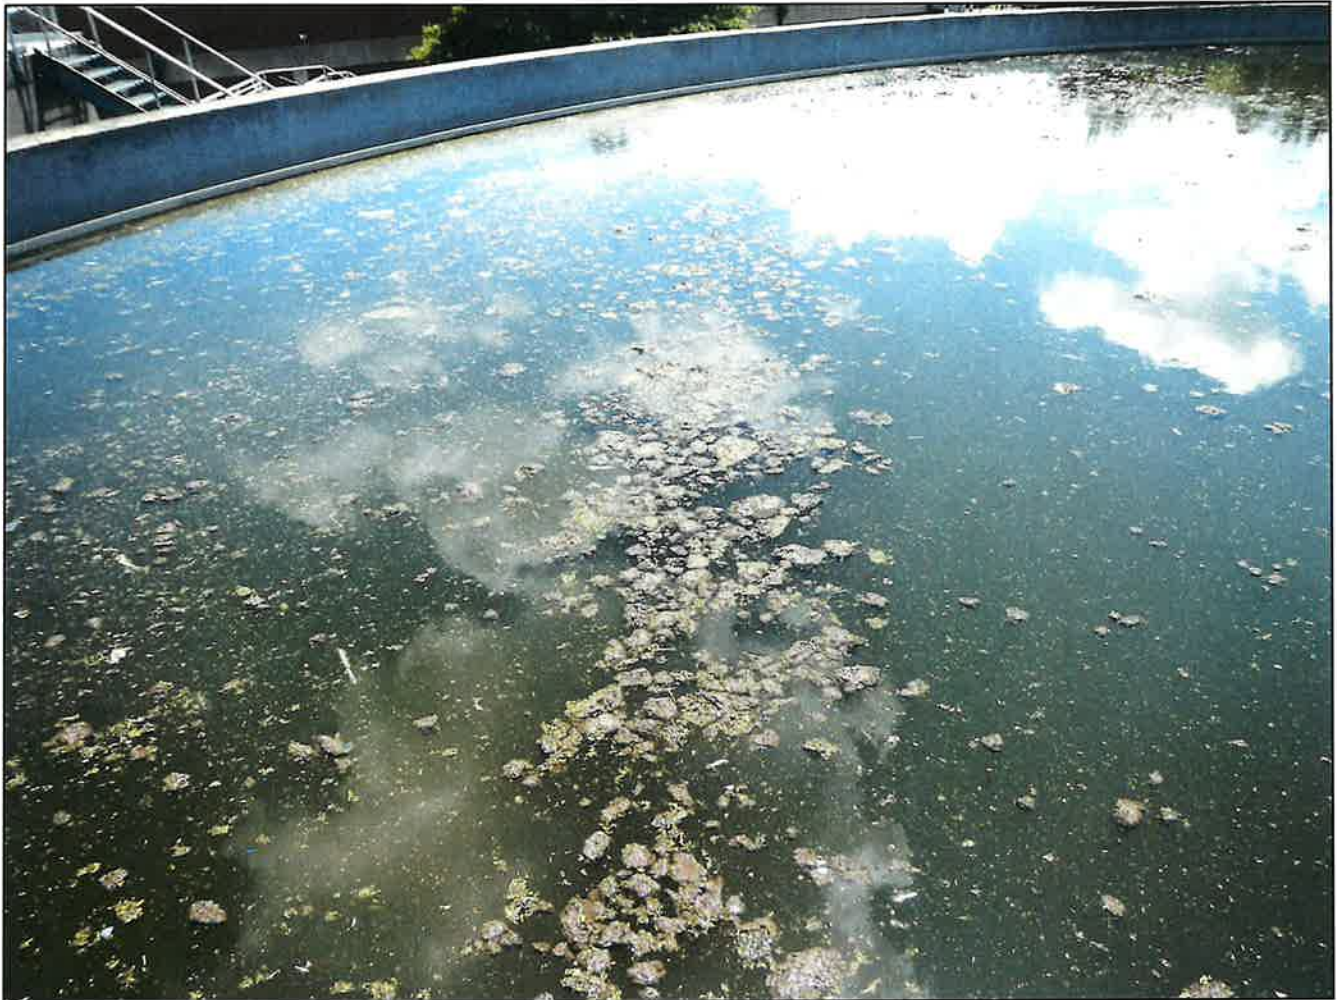
Photo 14. Secondary Clarification – Clarifier #6 with abundant floating solids.

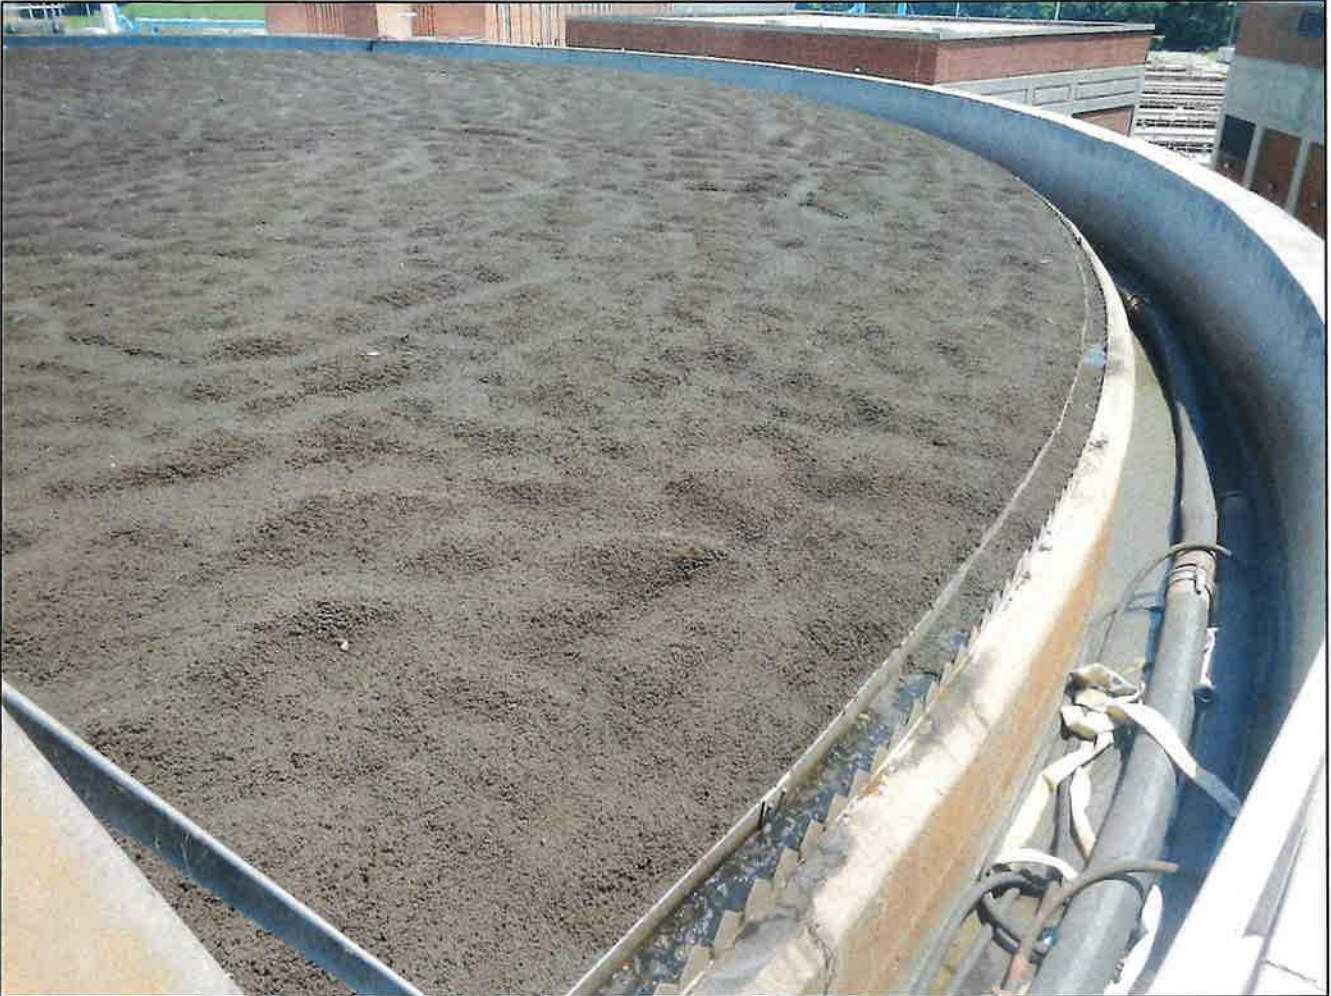
Photo 15. Secondary Clarification – Clarifier #8 (out of service) with effluent channel cleaned out and with floating solids blanket.

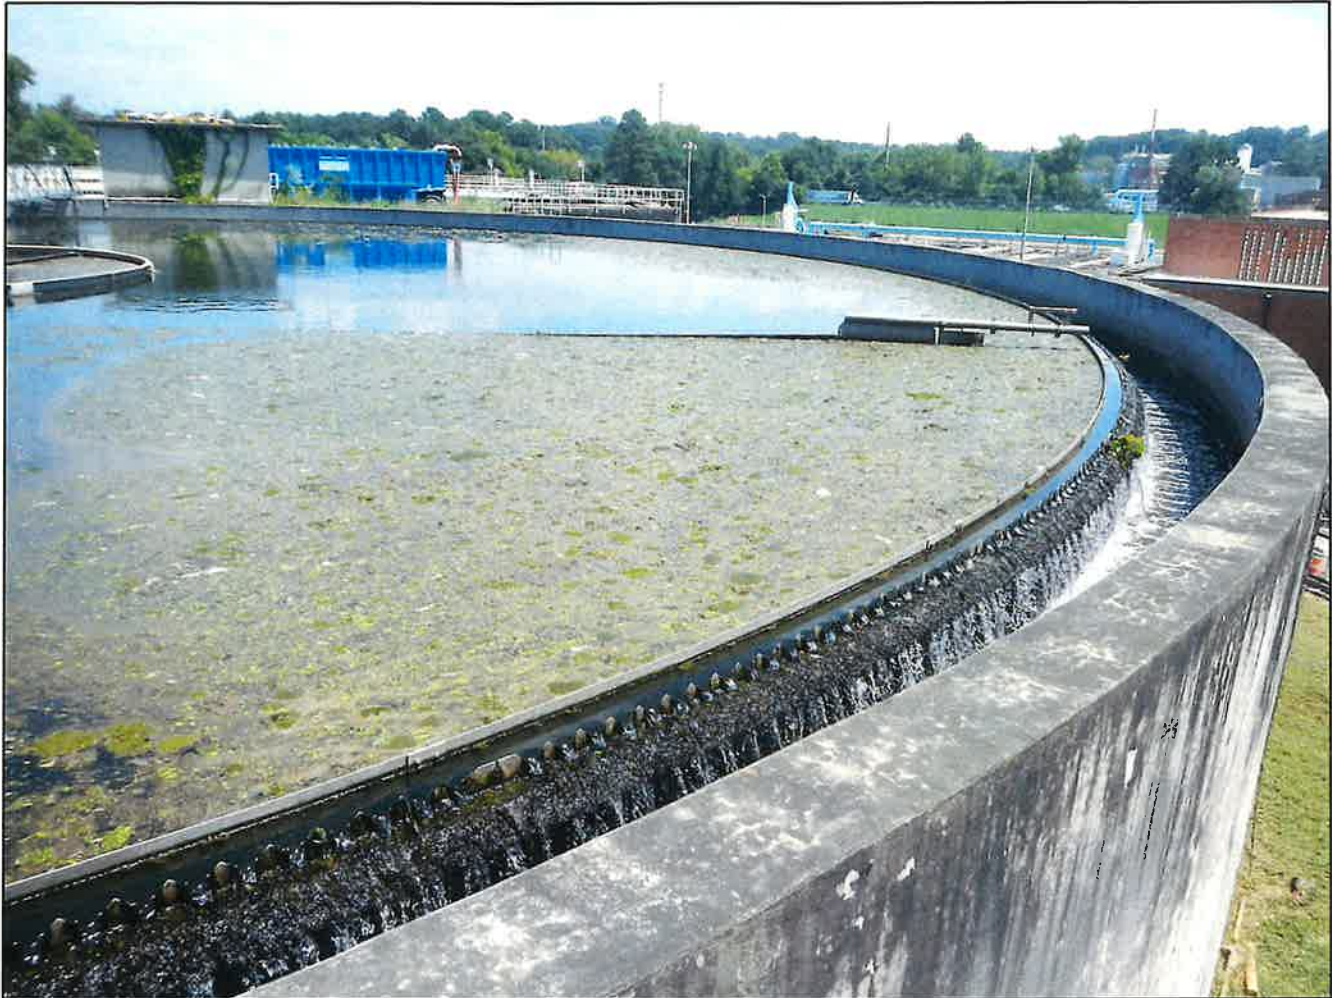
Photo 16. Secondary Clarification – Clarifier #10 in operation with floating solids blanket covered with plant life, and with abundant algal growth built up on the weir and effluent channel.

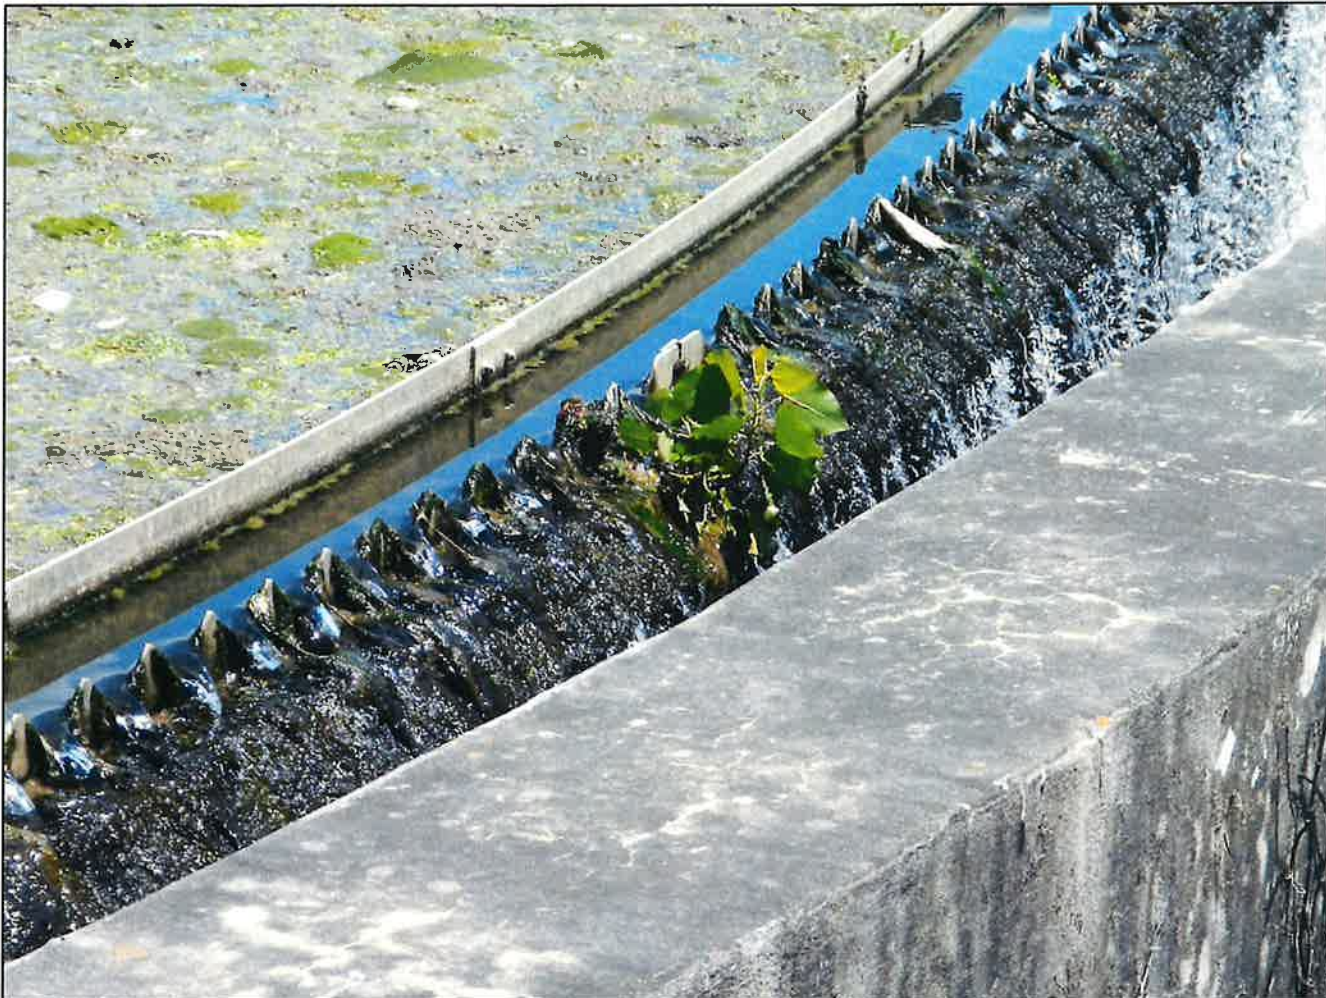
Photo 11. Secondary Clarification – Clarifier #10 with advanced plant growing out of effluent weir among abundant algal growth and debris depth built up on the weir and effluent channel.

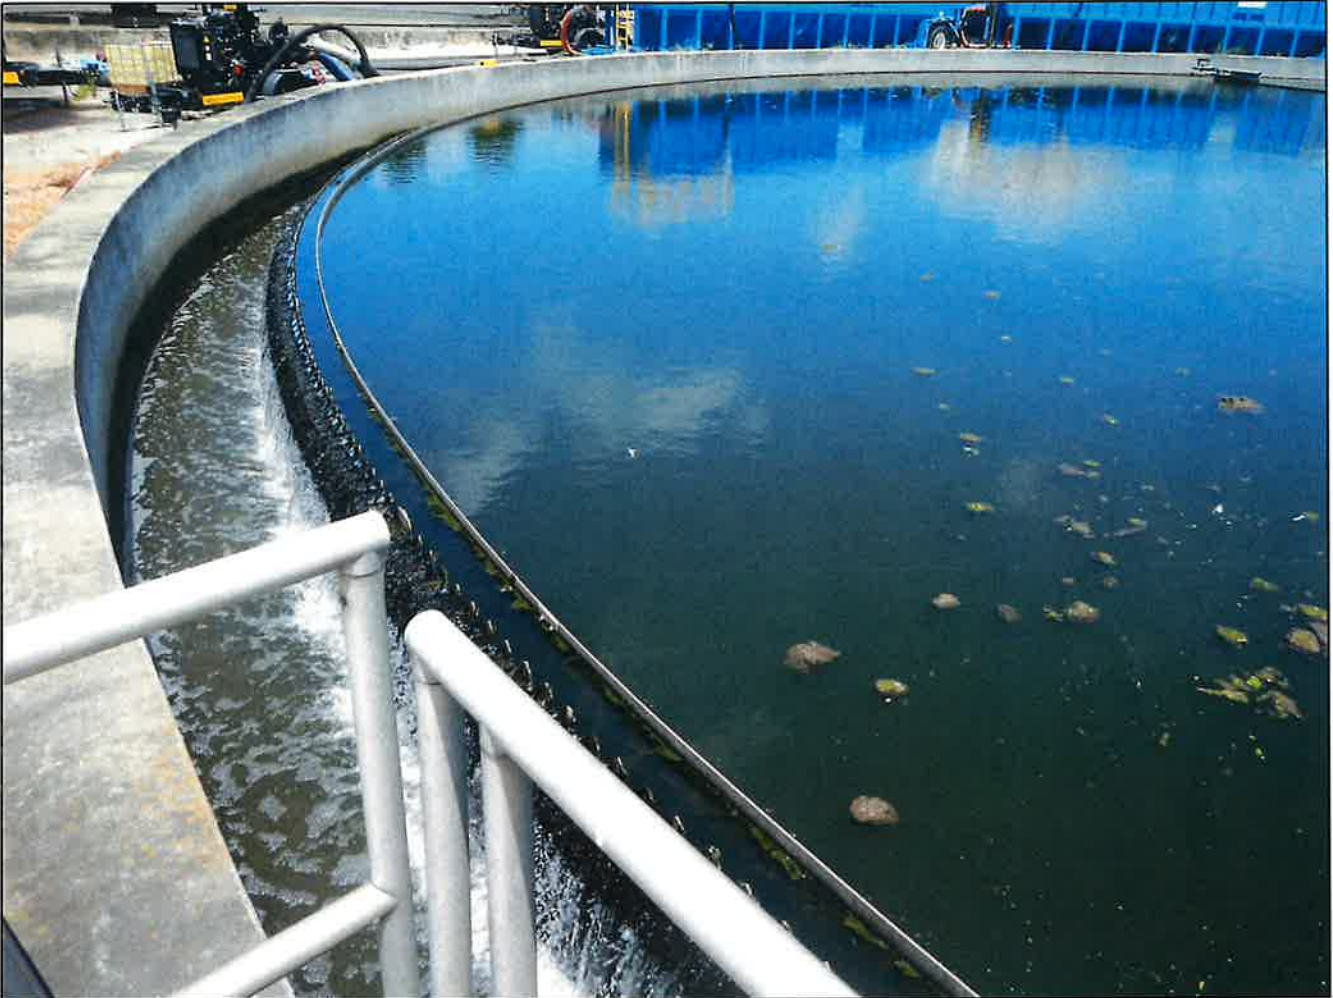
Photo 18. Secondary Clarification – Clarifier #10 with abundant floating solids and effluent channel with turbid effluent.

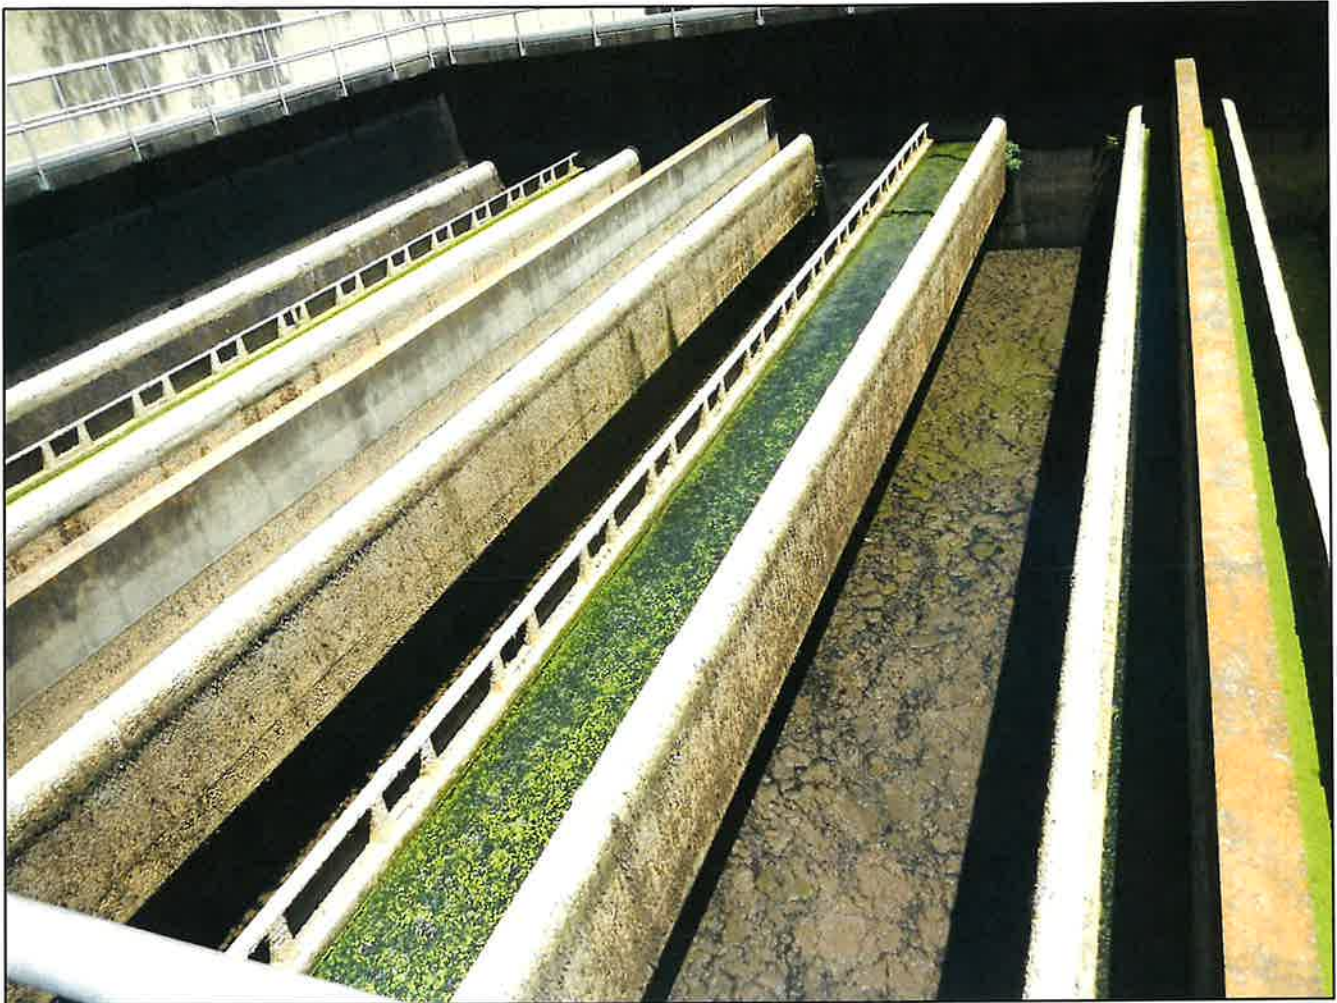
- g. *Tertiary systems.* Six of the 22 deep bed granular media filters were not in operation. Units 3, 9, and 13 were off-line due to solenoid failures that allow the units to run automatically. Plant staff noted they could be run manually if necessary. Units 18, 20, and 22 were off-line for scheduled preventive maintenance. The operating filters were observed being backwashed and loading flow to filter. A large temporary tank of sodium hypochlorite solution was stationed before the filters.

Photo 19. Tertiary Treatment – Media filters #18, 20, and 22 (out of service).
